Inspection Report

5690 Anywhere Drive
Milton NC 27893

Stephen and Son Home Inspection Services, LLC

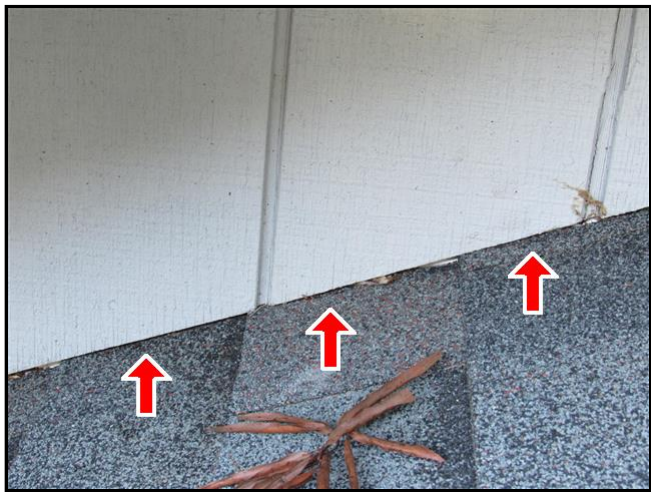
1.1 Item 1(Picture)

1.1 The siding on the left side of the house over the bedrooms touches the roof in several places. When wood siding touches the roof shingles it can wick water causing damage to the wood siding. During my inspection I did not find any of these areas where rot was present, however to prevent damage from occurring I recommend that a qualified contractor inspect and make any necessary repairs.

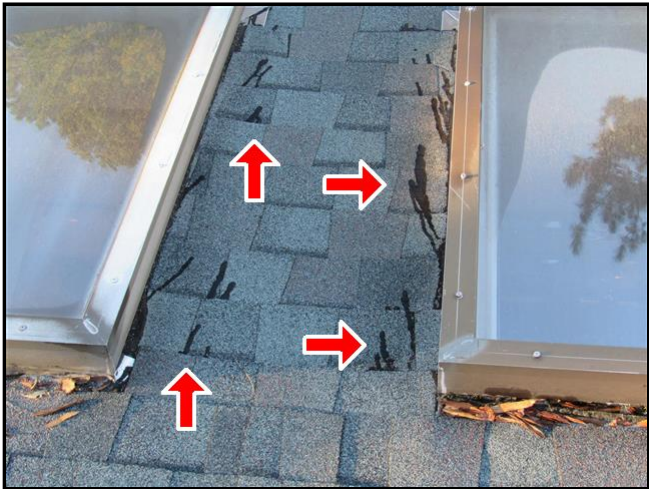
1.2 Item 1(Picture)

1.2 The roof shingles on the front of the house in between the two skylights and over the kitchen have roof cement dripped on the shingles. There is also a large amount of roof cement around the skylights. This is indicative of a roofing repair for a possible leak. Also, I found a nail popped up on one of the skylight flashings. I recommend a qualified roofer inspect the skylight penetrations, determine if leaks are present, and make any necessary repairs.

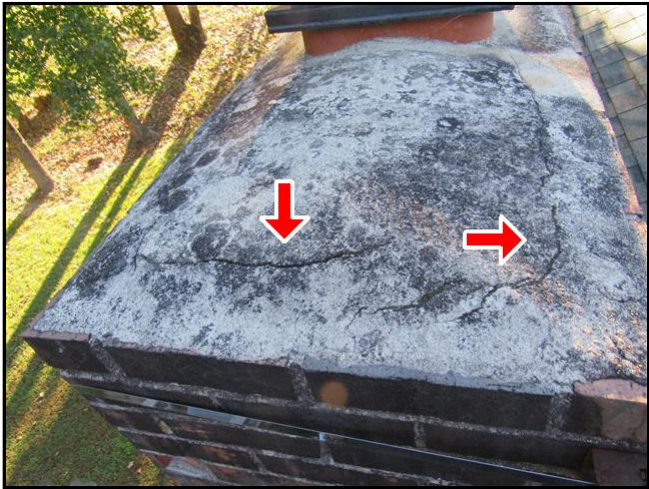
1.2 Item 3(Picture)

The top of the chimney cap has several small cracks which over time will allow water penetration and failure of the cap. I recommend a a qualified mason evaluate the chimney cap and make any necessary repairs.

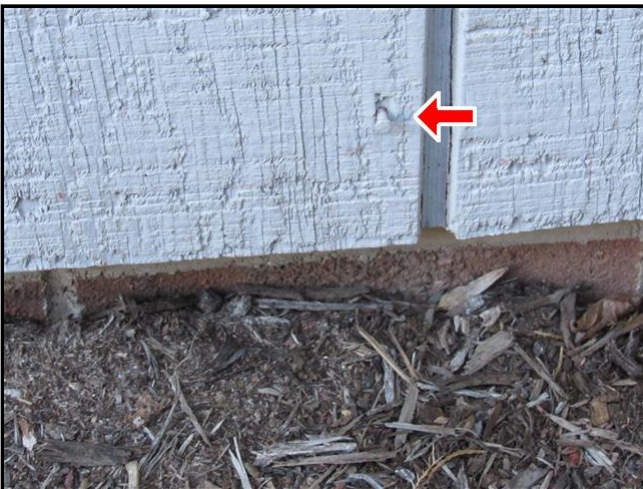
2.0 Item 3(Picture)

2.0 The wood trim on the left side of the garage door is rotted at the bottom. The hole in the bottom can lead to pest infestation. Also, the wood trim on the right side of the door is off the ground several inches. It is common practice to maintain distance between the wood and the ground to prevent water from wicking and future rot, however in this case it is such a large hole that pests could enter the garage. I recommend a qualified contractor inspect and make any necessary repairs.

The wood siding on the front of the house at the bottom near the garage is coming loose and popping out. A nail can be seen popped out from the siding. I recommend a qualified contractor inspect and make any necessary repairs.

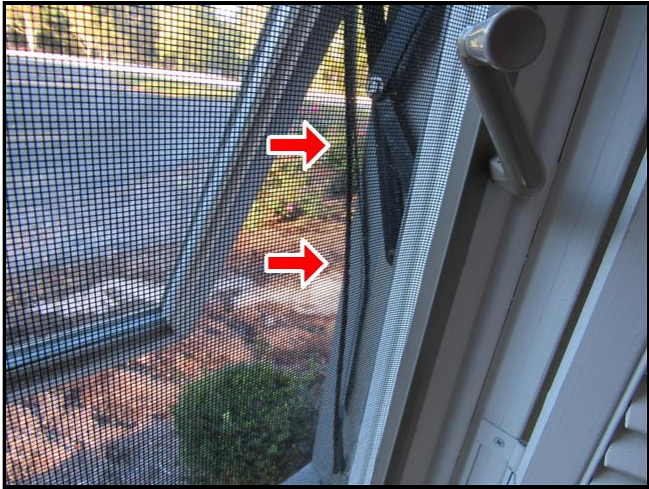
2.2 Item 1(Picture)

2.2 The casement window gasket is broken in the bedroom at the front of the house on the left side and the screen will not close. Also, the casement window on the front bedroom on the left side has a gasket that is broken. The gasket prevents water and air penetration into the home. I recommend that a qualified contractor inspect and make any necessary repairs.

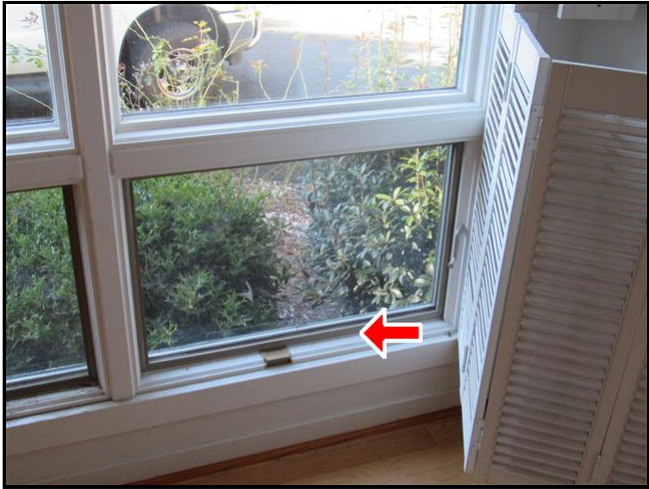
2.2 Item 5(Picture)

The right side window in the Dinette area off the kitchen and the kitchen windows near the laundry room will not open. I recommend that a qualified contractor inspect and make any necessary repairs.

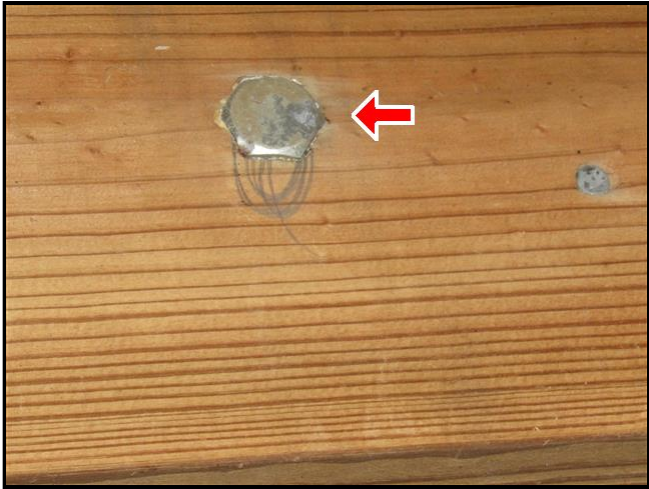
2.3 Item 1(Picture)

2.3 The band for the rear deck is attached with bolts, however the bolts do not have washers and have counter sunk into the wood. In normal construction practices, washers are used behind the bolts to prevent bolt penetration into the wood. I recommend that a licensed contractor be consulted to inspect and make any necessary repairs.

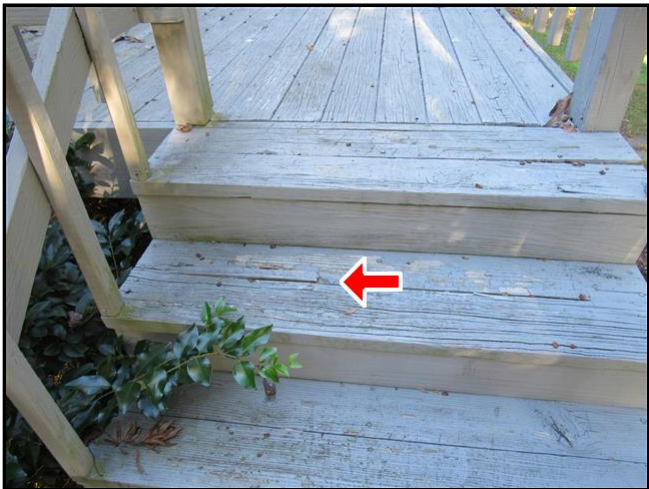
2.3 Item 9(Picture)

The top stair tread to the deck is rotted and splintering. This could lead to the failure of the tread. I recommend that a licensed contractor be consulted to inspect and make any necessary repairs.

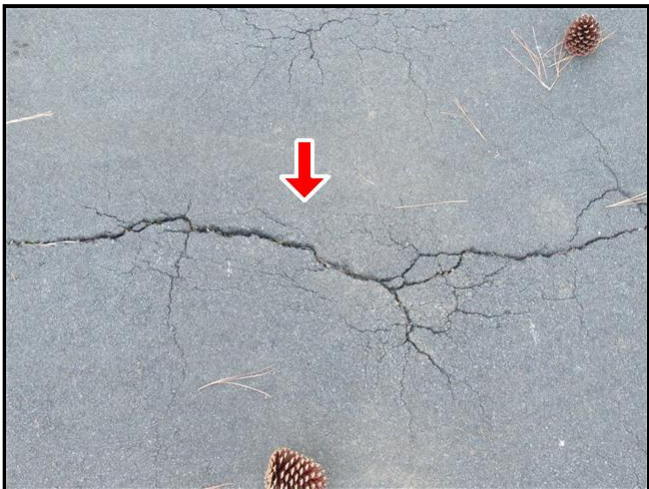
2.4 Item 1(Picture)

2.4 The driveway on the left side of the house near the road appears to be heaving upward. This may be caused by roots from a tree. This could be a trip hazard for people walking to the home from this side of the driveway. I recommend that a qualified contractor inspect and make any necessary repairs.

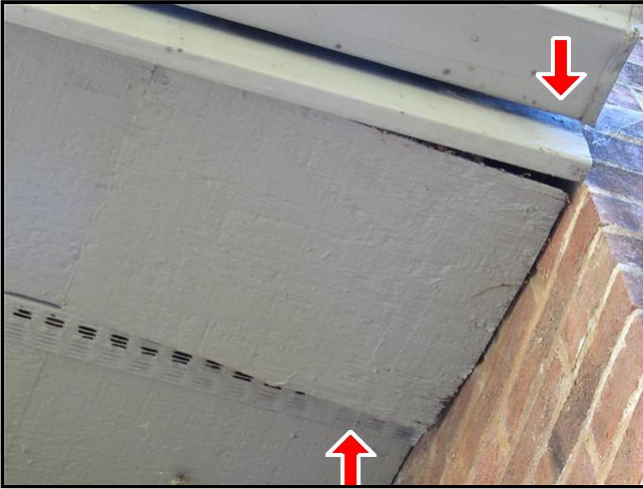
2.5 Item 1(Picture)

2.5 The soffit on the rear of the house next to the left side of the chimney is not secured and is pulling down. This could lead to pests entering the attic of the home. Also the gutter is pulling away from the fascia board next to the chimney. I recommend that a qualified contractor inspect and make any necessary repairs.

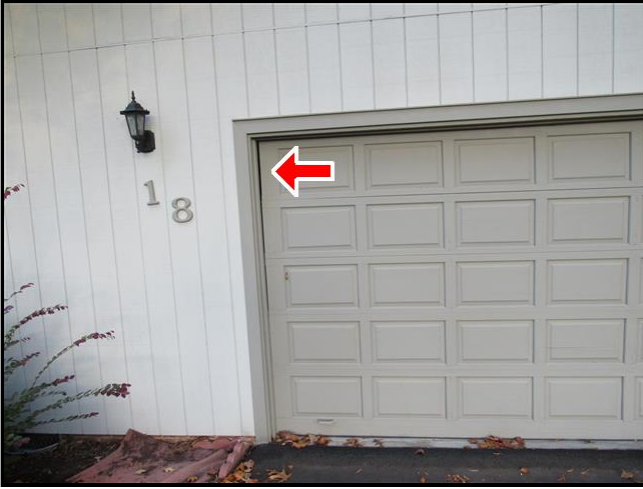
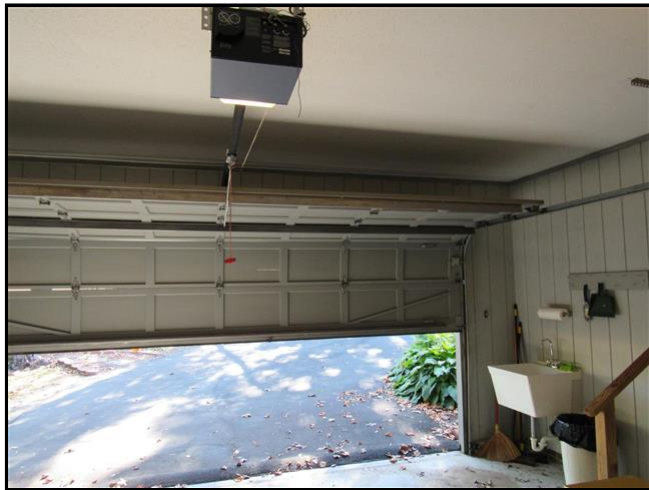
3.3 Item 1(Picture)

3.3 The garage door has a large space on the left side between the door and trim as well as a large space on the right side at the top between the door and trim. A screw is missing from one of the inside braces holding the door. The door appears to be out of square. When I tried to operate the automatic door opener it would only raise the door half way and then it stopped. A qualified garage door contractor should be consulted to inspect and make any necessary repairs.

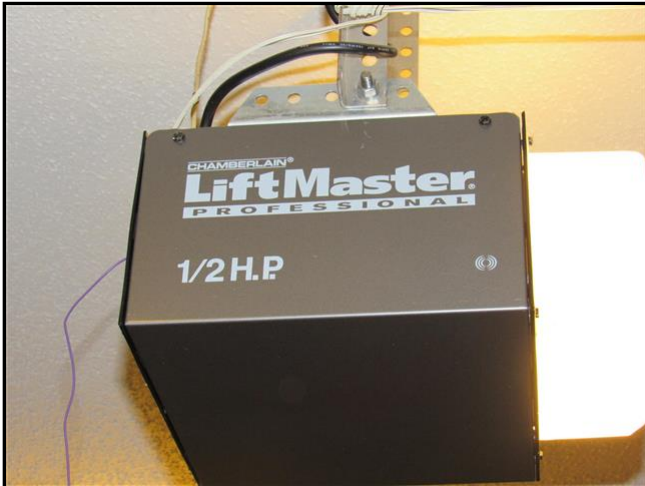
3.5 Item 1(Picture)

3.5 Once the garage door is repaired a qualified garage door contractor should inspect the door opener for proper operation.

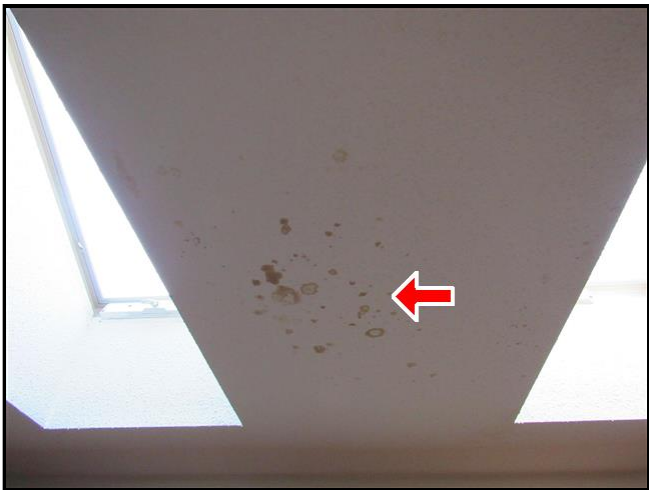
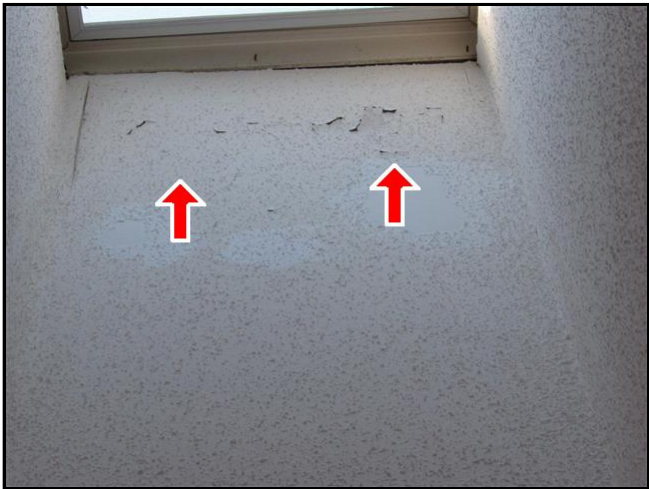
4.0 Item 1(Picture)

4.0 Stains on the ceiling in the kitchen between the sky lights visible at the time of the inspection appeared to be the result of roof leaks. The moisture meter showed elevated levels of moisture present in the affected areas at the time of the inspection, indicating that the leakage may have been recent. Also peeling textured paint was visible on the sheetrock near the skylight. A licensed contractor should be consulted to identify the source of the leak and repair as necessary.

The textured paint near the skylights in the bathrooms was peeling which may be an indication of excessive moisture. A licensed contractor should be consulted to determine the cause of the peeling and make any necessary repairs.

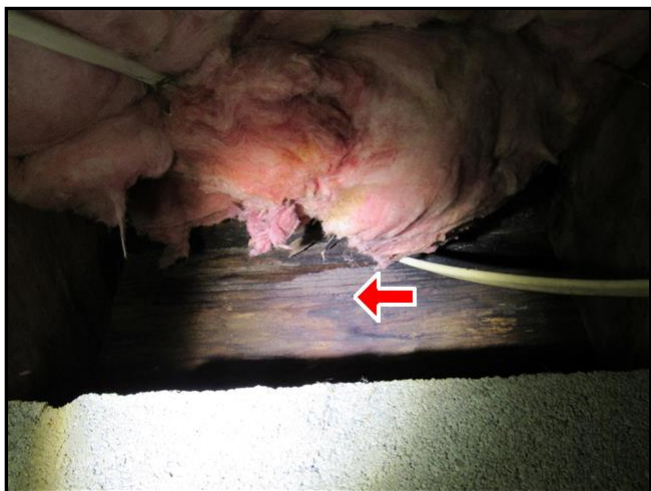
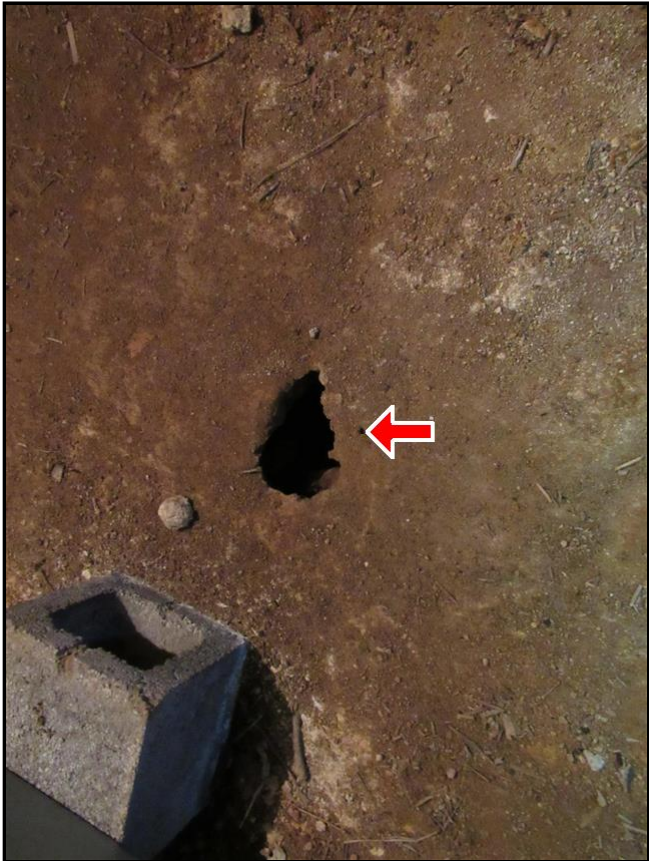
5.0 Item 1(Picture)

5.0 In the crawl space near the chimney and deck the outer wood band has dark black stains and is moist to the touch indicating moisture. The insulation near the band was wet when I pulled it down to observe the band. The crawl space does not have a vapor barrier on the floor. A licensed general contractor should be consulted to determine the cause of the moisture and make any necessary repairs.

In the crawl space that is not walkable under the laundry area I found a very wet area in the corner on the outer wood band and wood subfloor. It also appears to be fungal growth on the wood subfloor. A licensed general contractor should be consulted to determine the cause of the moisture, and make any necessary repairs to include cleaning the fungal growth.

In the crawl space near the HVAC unit I found two holes that seem to get smaller as they go further in the ground. I was unable to determine how the holes were made, whether by animal or water. I recommend a qualified contractor be consulted to review and make any necessary repairs.

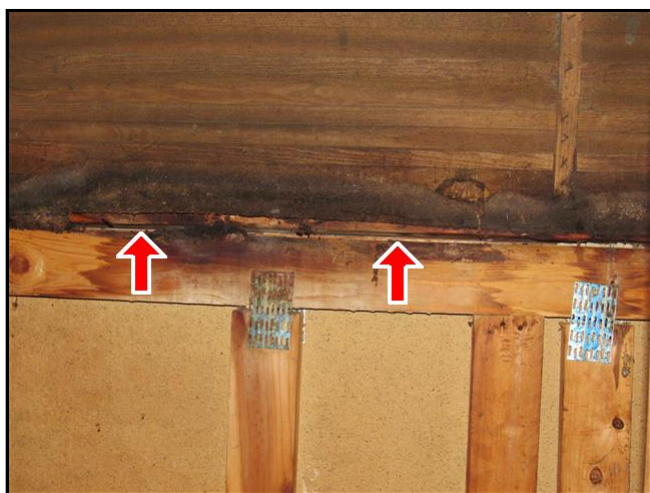
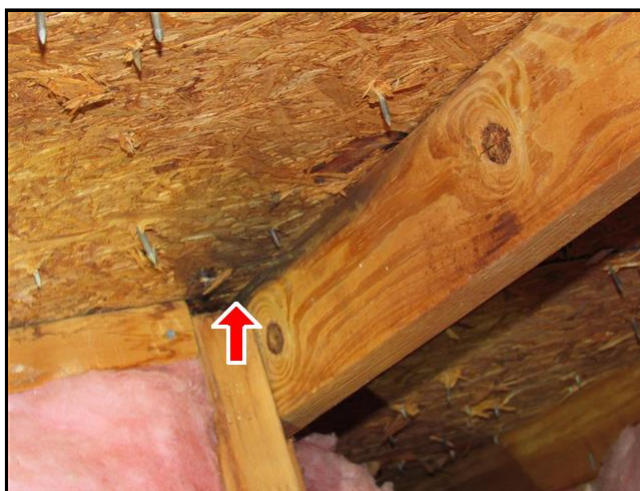
5.5 Item 1(Picture)

5.5 In the attic at both ends of the gable vent I observed the screen separating the interior of the attic from the exterior, broken at the bottom of the vent with large quantities of possible bat guano on the screen. I also observed a mound of possible bat guano on top of the insulation and below the vent near on the end of the house near the master bedroom. A qualified contractor should be consulted to repair the screens and also clean the possible bat guano.

In the attic near the location of the skylights at the master bedroom side of the house I observed discoloration of the roof truss from possible water penetration. At the time of this inspection the discoloration did not appear to be wet, however as stated earlier in the report, a licensed contractor should be consulted to determine if leaks are present and make any necessary repairs.

In the attic area near the location of the skylights above the kitchen I observed discoloration of the roof sheathing from possible water penetration. At the time of this inspection the discoloration did not appear to be wet, however as stated earlier in the report, a licensed contractor should be consulted to determine if leaks are present and make any necessary repairs.

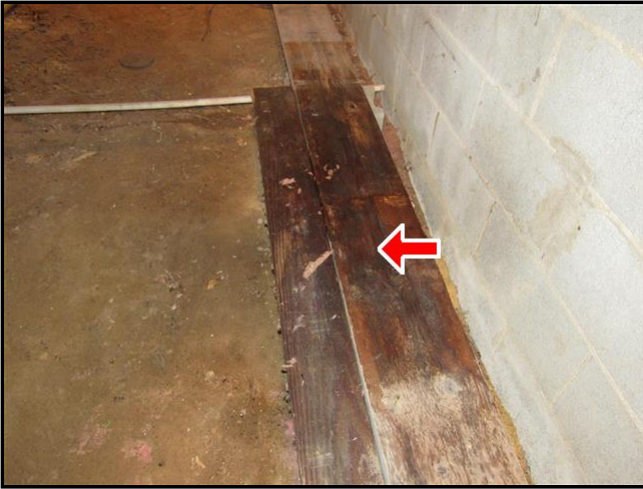
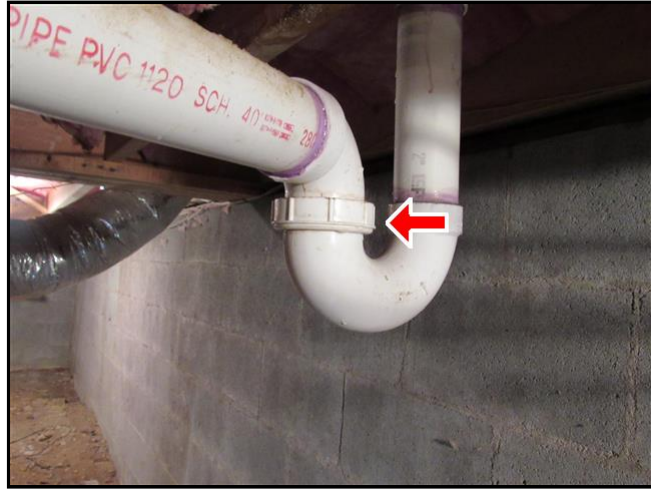
6.0 Item 1(Picture)

6.0 In the crawl space just as you enter from the basement access door I noticed the wood on the crawl space floor wet. I further noticed water dripping from the PVC drain pipe and trap directly above the wood. A licensed plumber should be consulted to evaluate the pipe and make any necessary repairs. Also, the wood should be removed from the crawl space floor so as not to attract wood destroying insects.

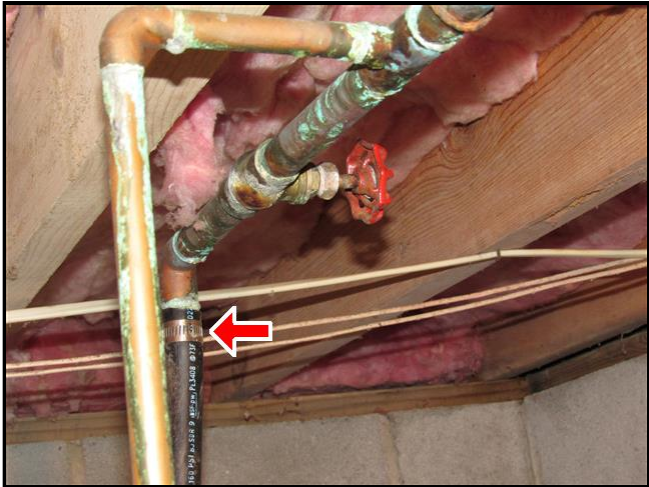
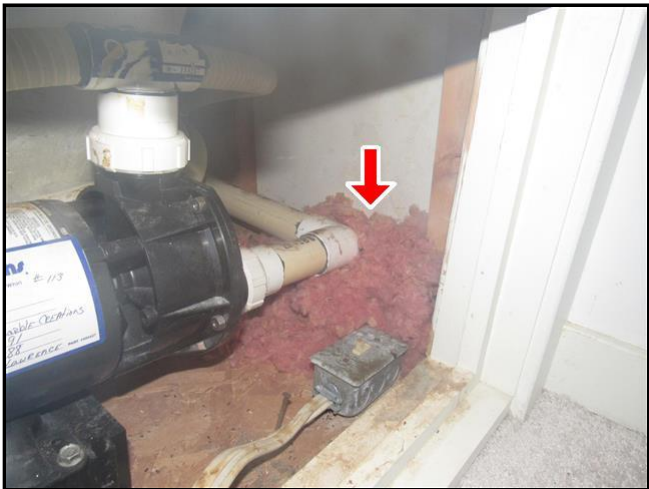
6.1 Item 1(Picture)

6.1 In the crawl space near the main water shut off and where the main water supply hose is connected to the copper supply pipe of the home a screw clamp is being used to connect the plastic pipe to the copper pipe. Screw clamps can become loose over time and with the main supply line under pressure this may cause a leak in the crawl space. I recommend that a licensed plumber be consulted to review the connection and make any necessary repairs.

The kitchen sink faucet has a noticeable leak at the handle when the water is turned to either hot or cold. When I inspected the faucet a large puddle of water began to run onto the back of the sink. I recommend that a licensed plumber be consulted to review the connection and make any necessary repairs.

The whirlpool tub in the bathroom has one jet that was not functioning at the time of inspection. Also, when I filled the tub with hot water, the water came out looking very orange. I recommend that a licensed plumber evaluate the tub and hot water heater and make any necessary repairs.

The access for the whirlpool tub had a small animal nest near the pump made out of insulation as well as animal droppings . It appears that the insulation came from the left side wall of the tub. I recommend that a qualified person remove the nest and animal droppings and also repair the insulation.

When I inspected the toilet in the master bath, I flushed the toilet with the use of the handle and I heard the sound of plastic breaking. When I took the top off of the tank I noticed that the float where it connects to the fill valve had broken off. I immediately turned the toilet water shut off valve to the off position. I recommend that a licensed plumber be consulted to review the connection and make any necessary repairs.

The same toilet in the master bath has signs of leaking around the base where the wood floor is discolored. At the time of inspection I did not feel water on the floor. I recommend that a licensed plumber be consulted to review the toilet connection to the floor and make any necessary repairs.

The vanity cabinet in the master bath had elevated moisture readings at the base and was very damp to the touch. During the inspection I did not find a leak in the pipes under the sink. I recommend asking the home owners for disclosure on whether something may have spilled or if a previous leak was repaired.

The hose bib on the outside of the house to the left of the garage was wrapped with cloth and plastic. I was unable to inspect it for proper function. I recommend that a licensed plumber inspect it for proper function and repair if necessary.

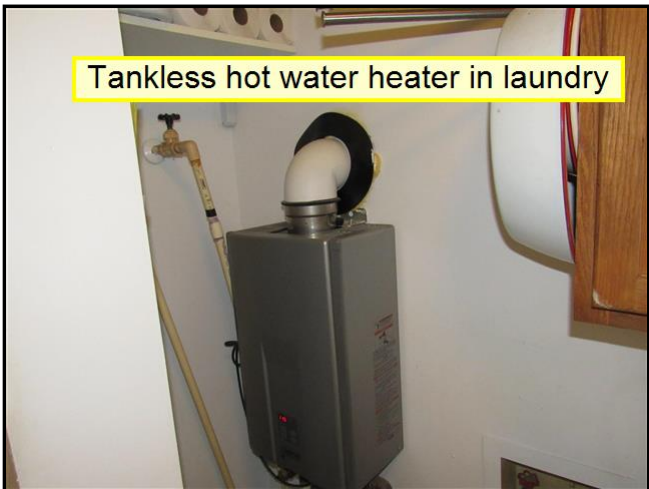
6.2 Item 1(Picture)

6.2 The tankless water heater located in the laundry room is missing a temperature pressure relief valve(TPRV). A TPRV is a safety device that is designed to release water if the tank safety pressure or temperature is exceeded. This is a serious safety concern and should be addressed. I recommend that a licensed plumber be consulted to inspect the water heater and make necessary repairs.

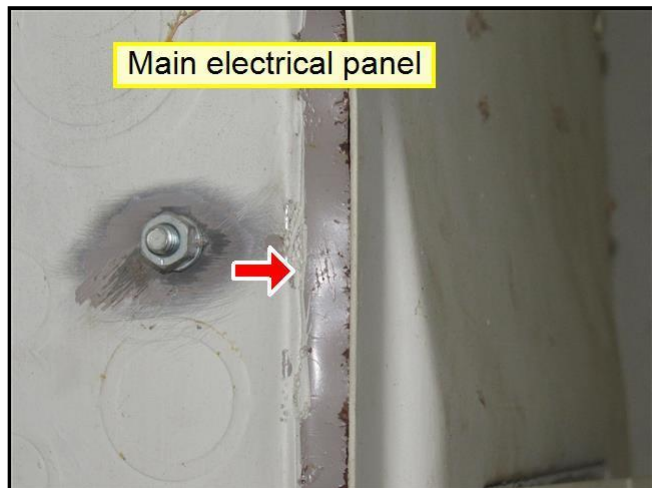
7.1 Item 1(Picture)

7.1 The left side of the main electrical panel located in the basement has been damaged on the left side preventing the outer door panel from securing properly. I recommend that a licensed electrician evaluate and make any necessary repairs.

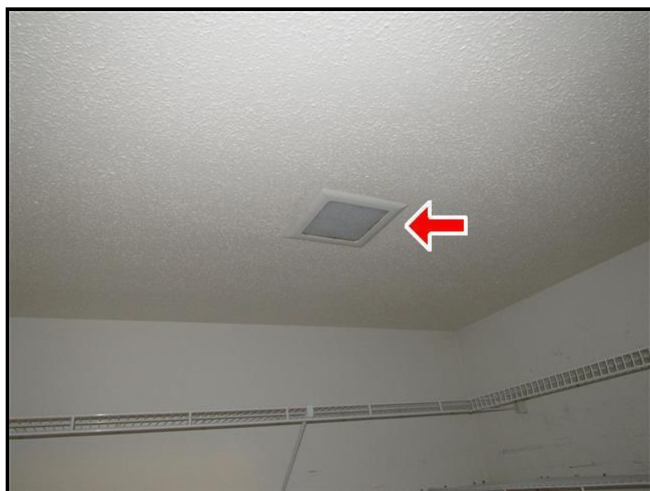
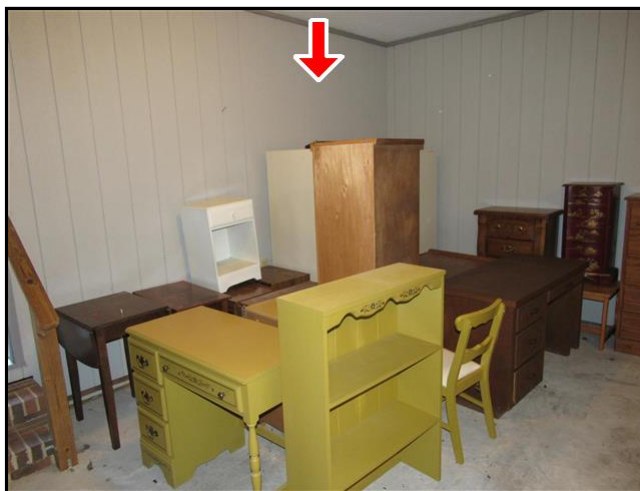
7.3 Item 1(Picture)

I was unable to test the electrical receptacles in the garage due to furniture storage on the wall of the garage. I recommend that a licensed electrician evaluate and make any necessary repairs.

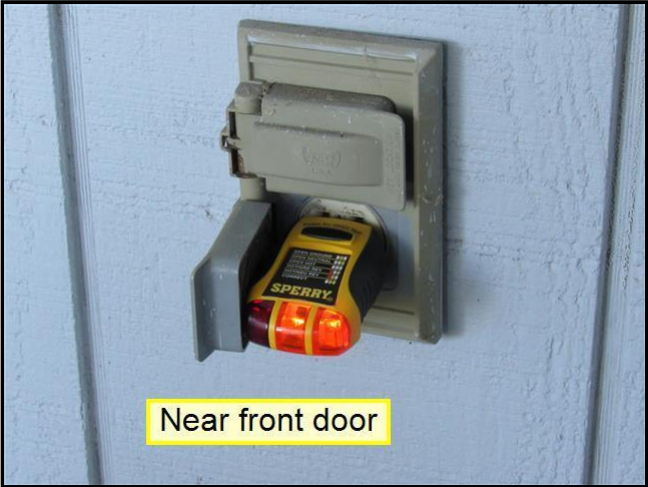
7.5 Item 1(Picture)

7.5 No ground fault circuit interrupter (GFCI) protection of home electrical receptacles was provided or the test function didn't work at the outside receptacles near the front door, master bath near the toilet, outlet above the wet bar sink, and outlet in the basement at the time of inspection. Although GFCI protection may not have been required at the time this home was built, for safety reasons,I recommend that electrical receptacles located in basements, crawlspaces, garages, the home exterior, and interior receptacles located within 6 feet of a plumbing fixture be provided with ground fault circuit interrupter (GFCI) protection in good working order to avoid potential electric shock or electrocution hazards. I recommend that a licensed electrician evaluate and make any necessary repairs.

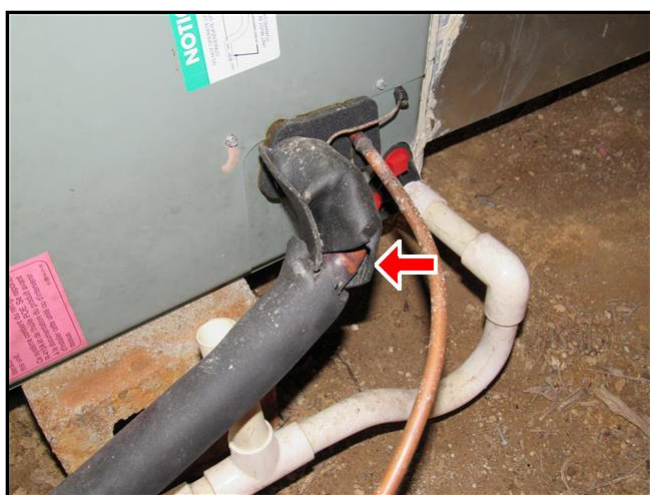
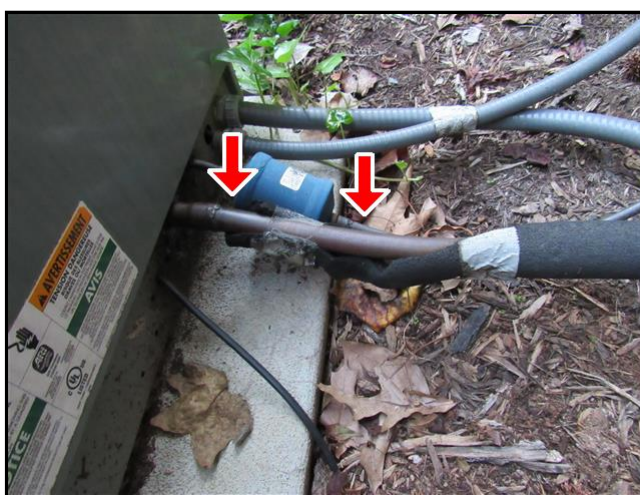
8.0 Item 1(Picture)

At the time of inspection the outside temperature was 37 degrees. I was able to test the function of the heat pump in the heating mode ,however because of the low temperature I was unable to test the AC mode. HVAC units should be serviced once per year by a qualified HVAC technician. I recommend asking the home owner when the last time the unit was serviced.

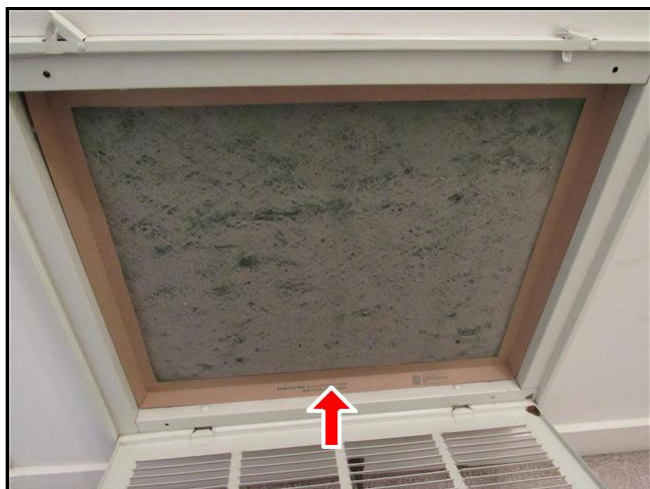
8.3 Item 1(Picture)

8.3 The return air filter located in the hallway near the two bedrooms was dirty at the time of inspection. A dirty filter can reduce the efficiency of an HVAC unit. I recommend replacing the filter.

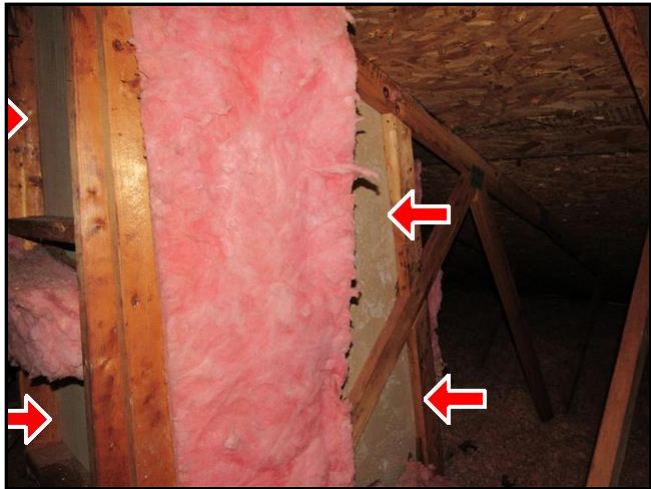
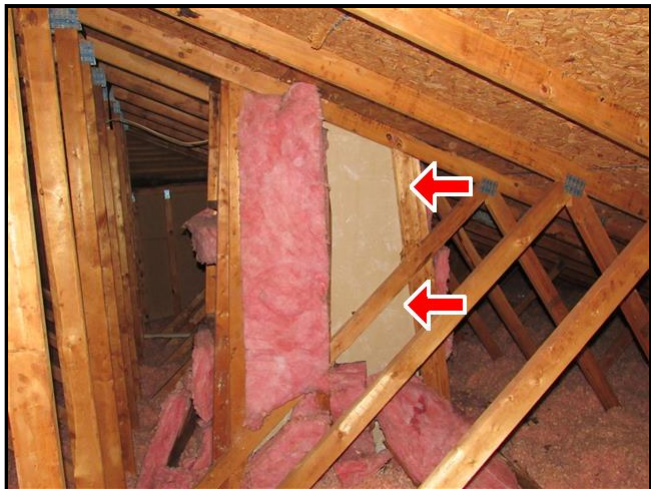
9.0 Item 1(Picture)

9.0 In the attic at the walls going up to the skylights insulation has fallen down and is missing in several areas. It is important to have insulation in areas where conditioned/heated spaces meet non conditioned/ heated spaces in order to prevent moisture. I recommend that a qualified contractor review and make necessary repairs.

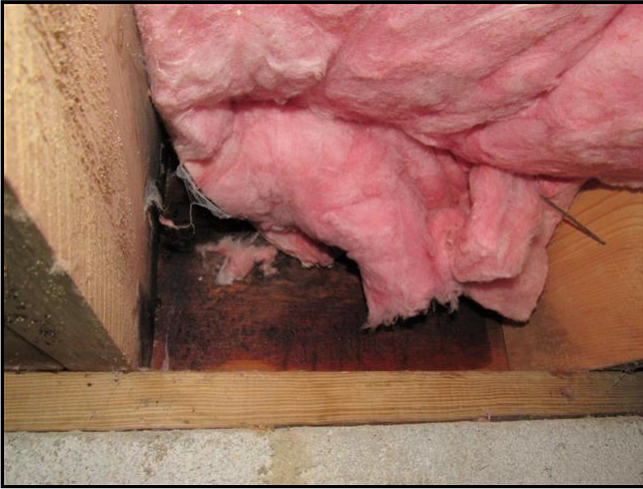
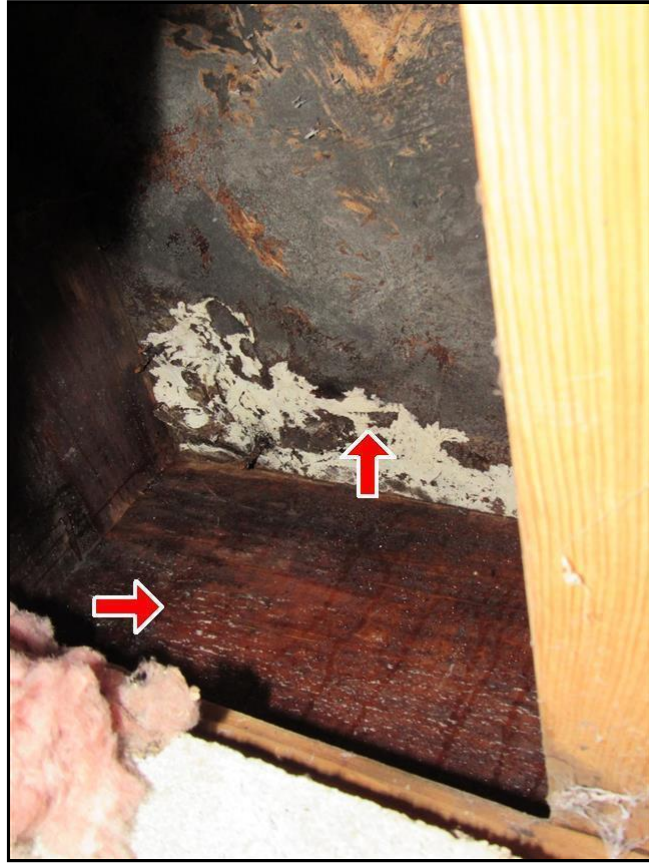
9.1 Item 1(Picture)

9.1 In the crawl space near the outer bands that were discussed earlier in the structural section, several pieces of insulation are wet causing the wood to darken and fungal growth. A qualified contractor should be consulted to review the wet insulation and make necessary repairs.

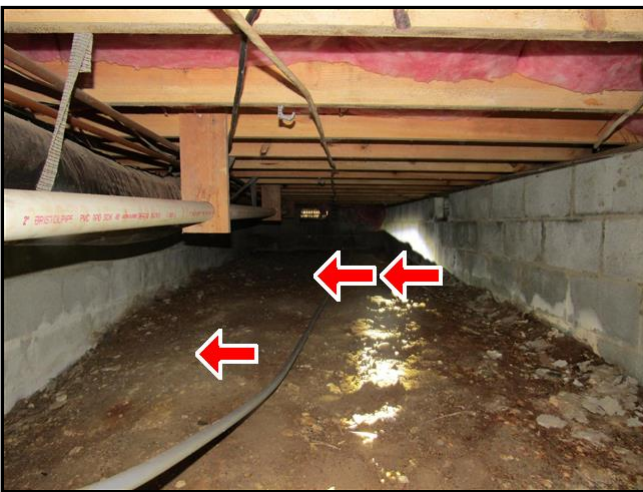
9.2 Item 1(Picture)

9.2 The crawl space did not have a vapor barrier installed on the crawl space floor. In the crawl space that has low clearance under the kitchen I found the dirt to be very moist. I recommend that a qualified contractor inspect and make the necessary repairs.

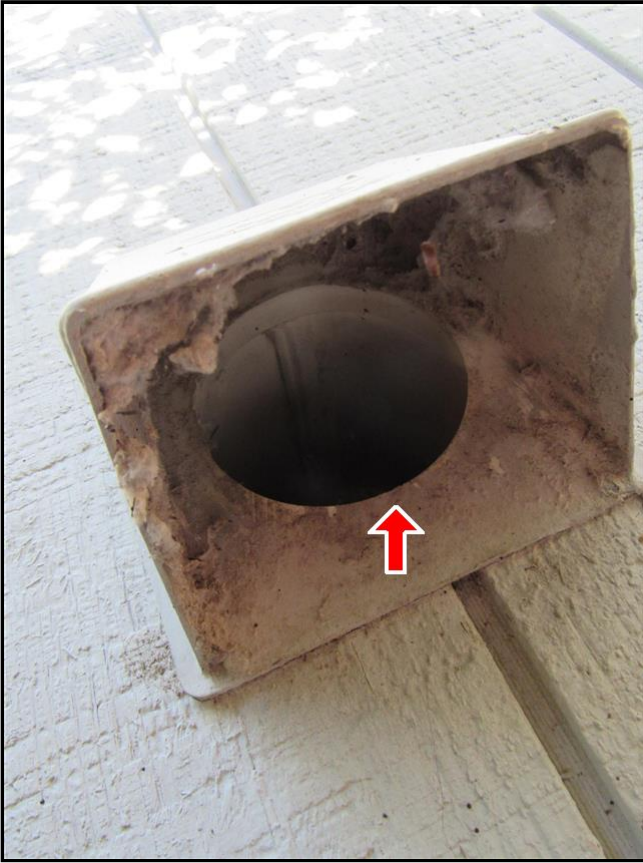
9.4 Item 1(Picture)

9.4 The exterior ventilation hood for the clothes dryer located to the left of the garage door is missing a hinged door that normally opens when the dryer is on and closes when it is off. This door prevents pests and air from entering the dryer vent. I recommend having a qualified contractor review and repair as necessary

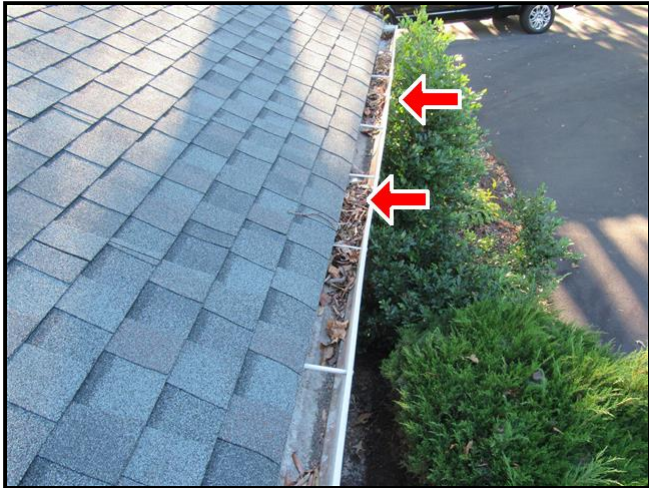
1.3 Item 1(Picture)

Some of the gutters have leaves inside which may prevent the the proper flow of water leaving the roof. I recommend having the gutters cleaned in order to provide for proper drainage.

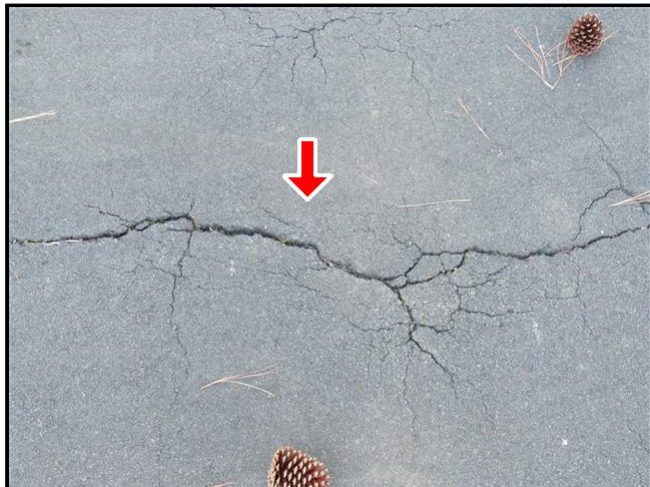
2.4 Item 1(Picture)

The driveway on the left side of the house near the road appears to be heaving upward. This may be caused by roots from a tree. This could be a trip hazard for people walking to the home from this side of the driveway. I recommend that a qualified contractor inspect and make any necessary repairs.

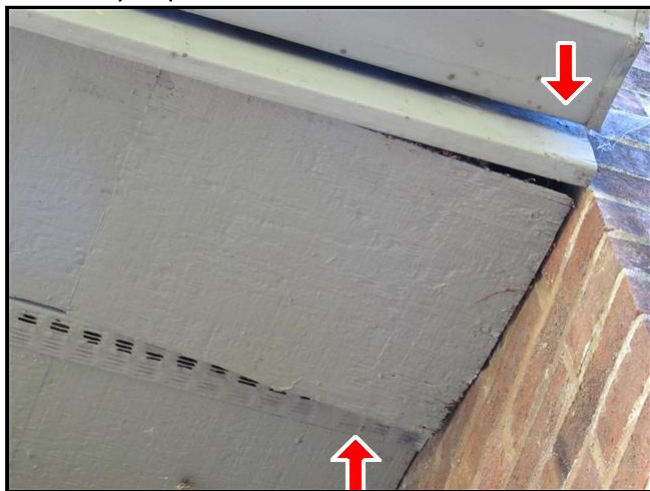
2.5 Item 1(Picture)

The soffit on the rear of the house next to the left side of the chimney is not secured and is pulling down. This could lead to pests entering the attic of the home. Also the gutter is pulling away from the fascia board next to the chimney. I recommend that a qualified contractor inspect and make any necessary repairs.

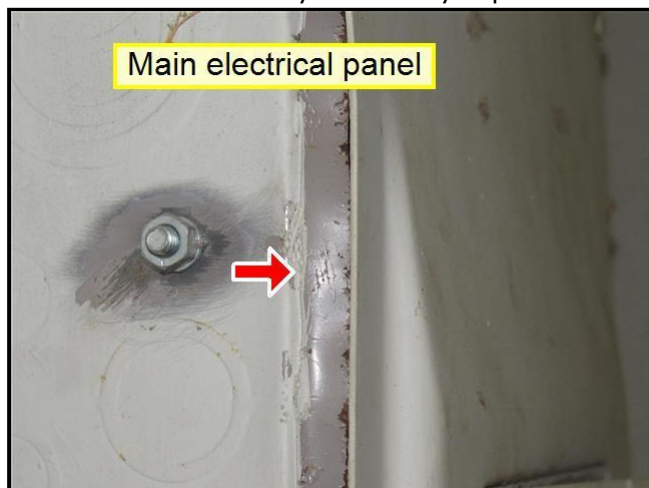
7.1 Item 1(Picture)

The left side of the main electrical panel located in the basement has been damaged on the left side preventing the outer door panel from securing properly. I recommend that a licensed electrician evaluate and make any necessary repairs.

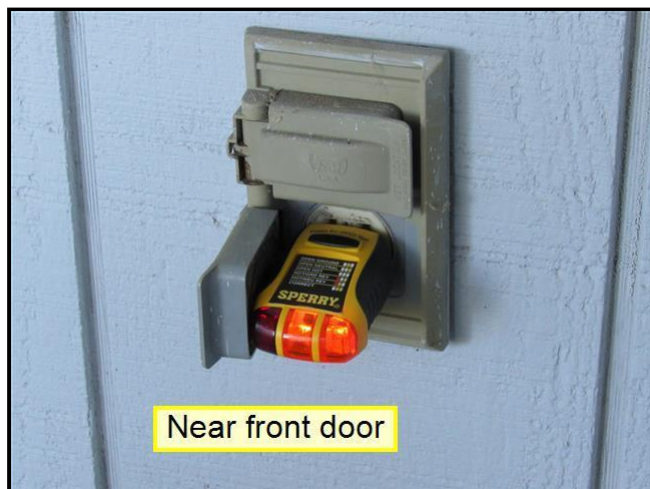
7.5 Item 1(Picture)

interrupter (GFCI) protection in good working order to avoid potential electric shock or electrocution hazards. I recommend that a licensed electrician evaluate and make any necessary repairs.

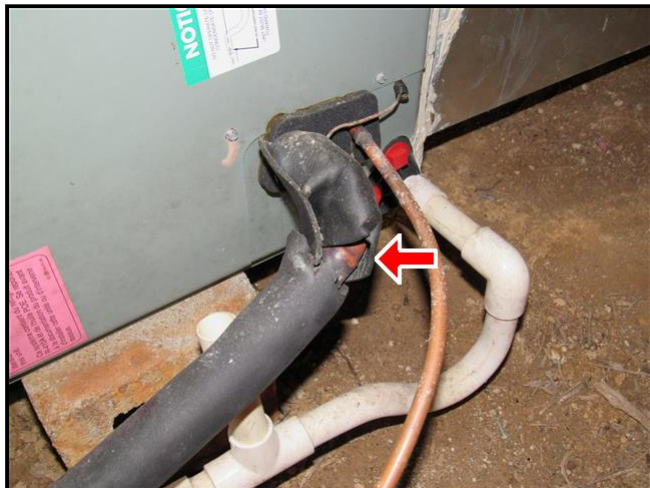
8.0 Item 1(Picture)

At the time of inspection the outside temperature was 37 degrees. I was able to test the function of the heat pump in the heating mode ,however because of the low temperature I was unable to test the AC mode. HVAC units should be serviced once per year by a qualified HVAC technician. I recommend asking the home owner when the last time the unit was serviced.

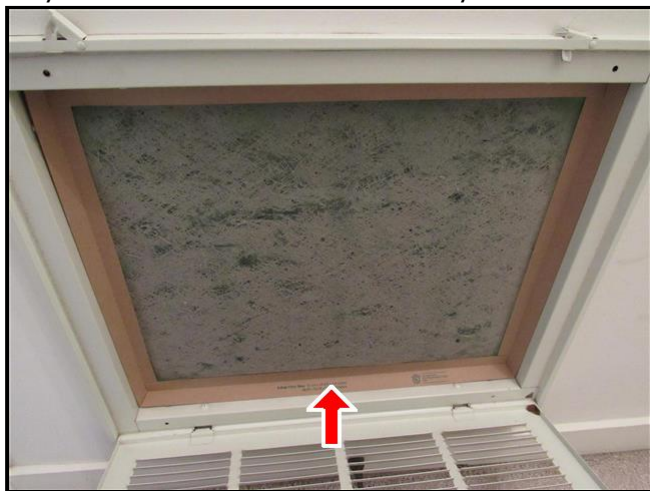
8.3 Item 1(Picture)

The return air filter located in the hallway near the two bedrooms was dirty at the time of inspection. A dirty filter can reduce the efficiency of an HVAC unit. I recommend replacing the filter.

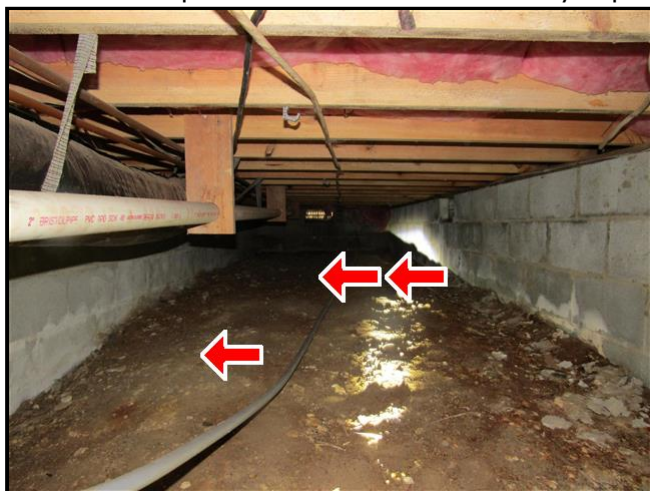
9.2 Item 1(Picture)

The crawl space did not have a vapor barrier installed on the crawl space floor. In the crawl space that has low clearance under the kitchen I found the dirt to be very moist. I recommend that a qualified contractor inspect and make the necessary repairs.

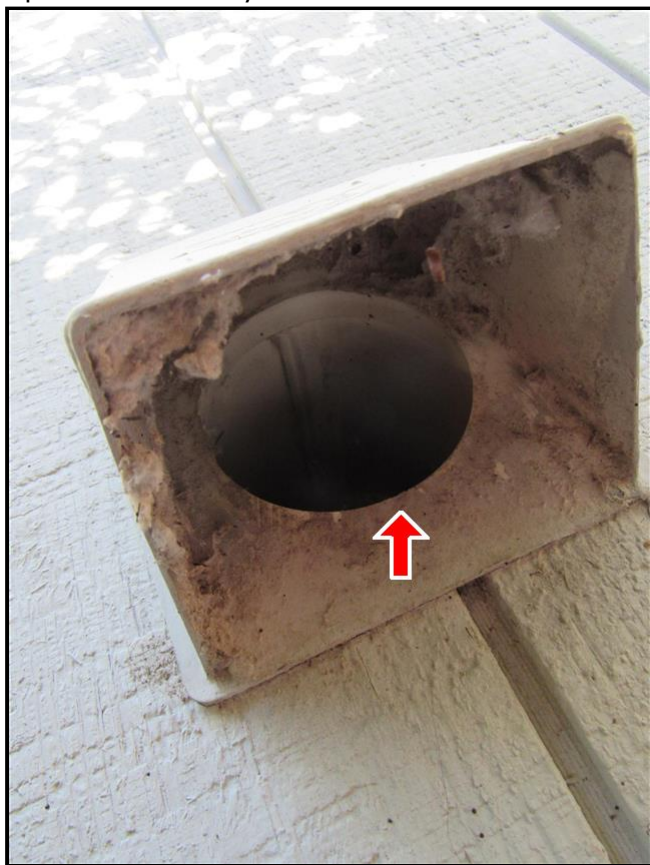
9.4 Item 1(Picture)

The exterior ventilation hood for the clothes dryer located to the left of the garage door is missing a hinged door that normally opens when the dryer is on and closes when it is off. This door prevents pests and air from entering the dryer vent. I recommend having a qualified contractor review and repair as necessary
