Inspection Report

3001 University Place
New City NC 56789

Stephen and Son Home Inspection Services, LLC

Date: 1/16/2014	Time: 08:00 AM	Report ID: Sample New Home
Property: 3001 University Place New City NC 56789	Customer: Frank and Joan Smith	Real Estate Professional:

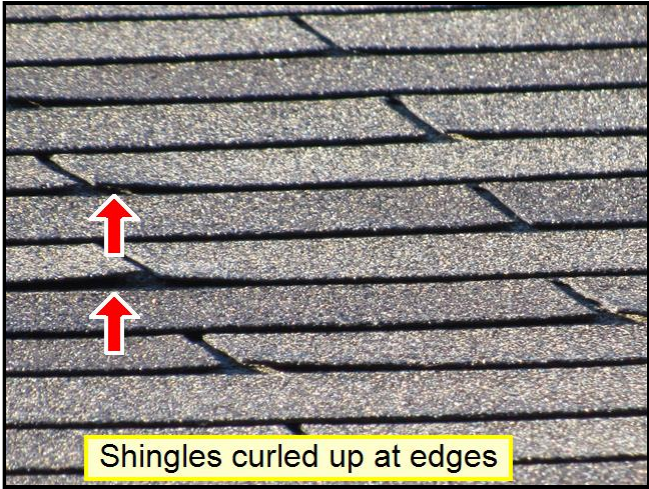
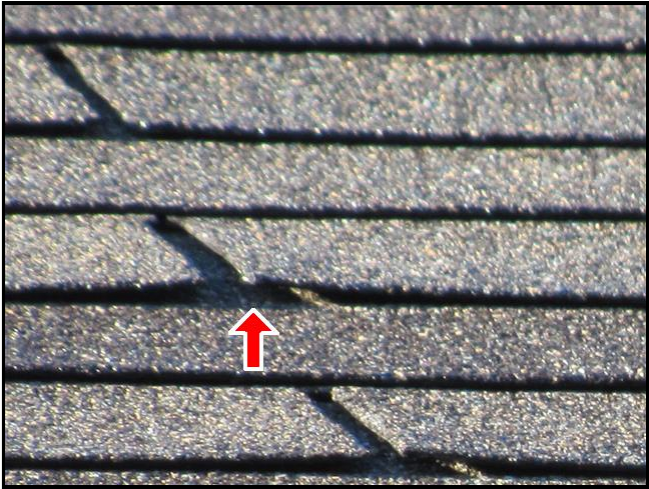
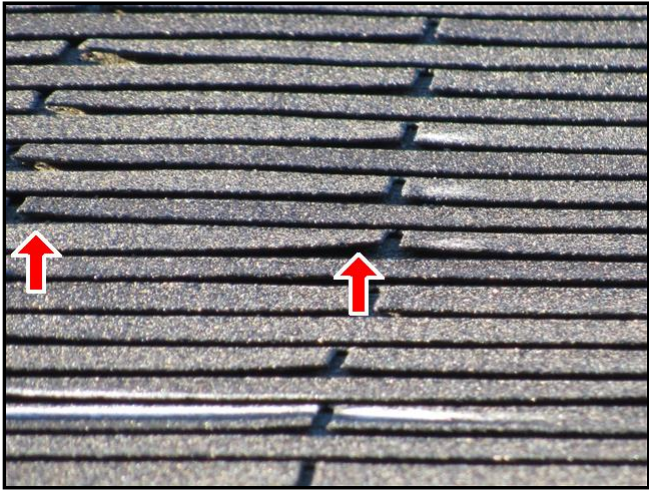
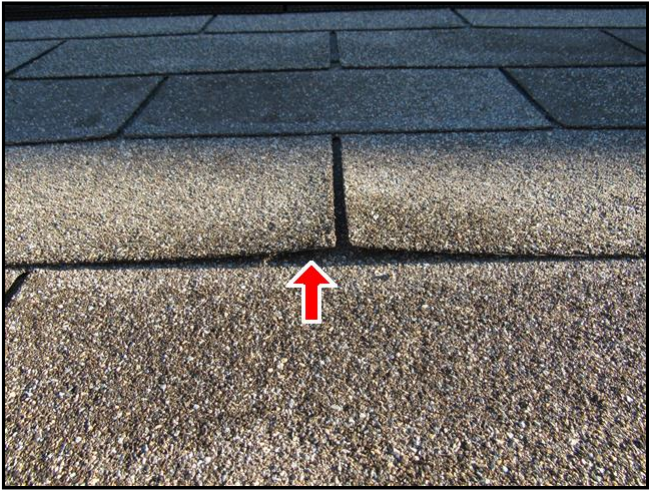
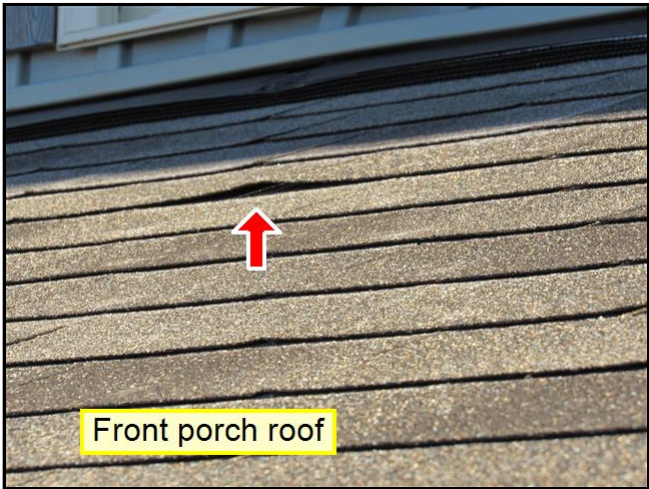
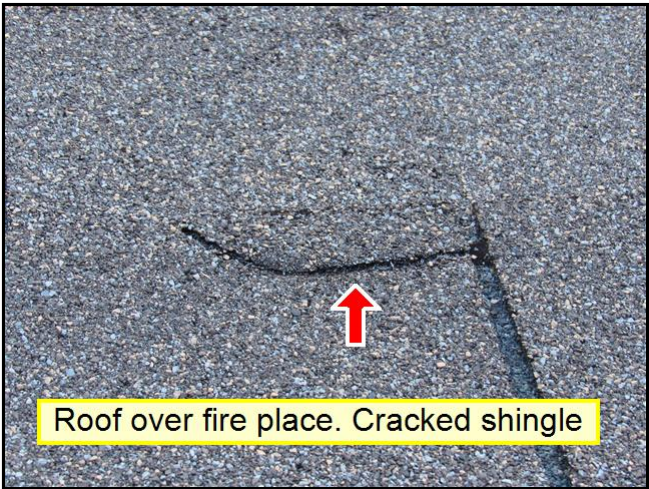
1.0 Several roof shingles on the rear of the house are curled up at the edges and are not laying flat. Also, one roof shingle on the front of the home over the porch is curled upward at the edge and not laying flat. Shingles that are curled upward can be caught in high winds possibly causing water penetration into the home and shingles to tear off. I recommend that a licensed contractor evaluate the roof and make any necessary repairs.

The roof over the fire place at the rear of the house has a cracked shingle. The shingle appears to have been cemented in place, however I recommend that a licensed contractor evaluate the roof and make any necessary repairs.

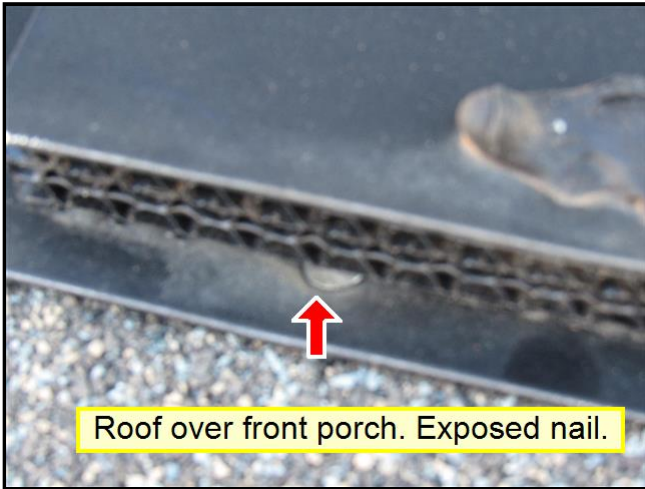
1.1 Item 1(Picture)

1.1 The roof over the front porch has an exposed nail over the counter flashing and near roof vent. Water could penetrate the roof at the nail causing damage to the home. I recommend that a licensed contractor evaluate the roof and make any necessary repairs.

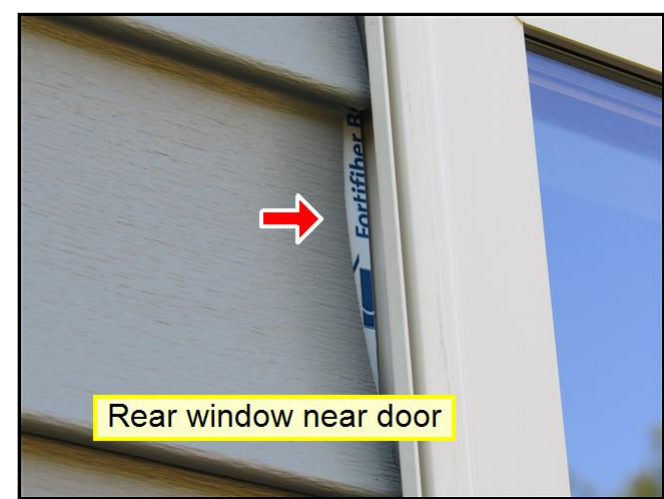
2.0 Item 1(Picture)

The exterior wall membrane can be seen around the window near the rear door. Vinyl siding needs to have expansion space, however the membrane with writing showing may be unsightly. This is a cosmetic issue.

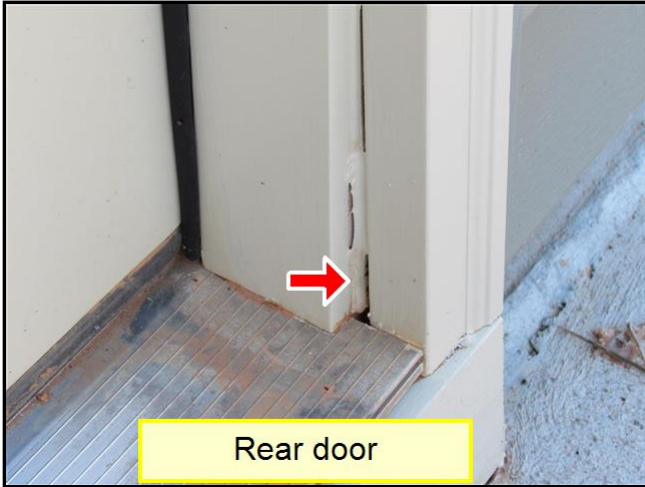
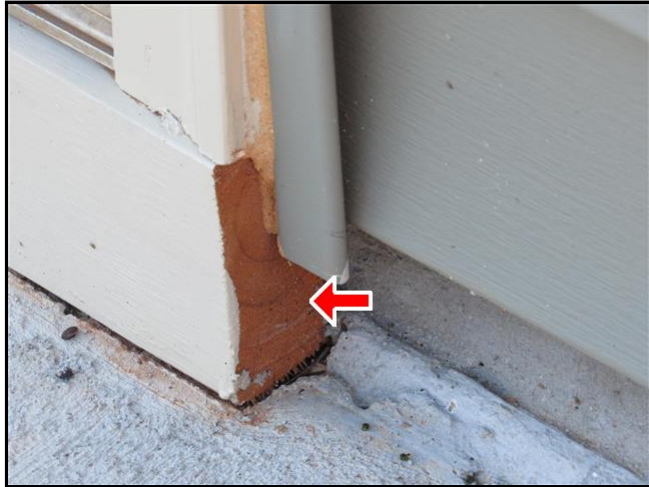
2.1 The right side casing of the rear door has a measurable gap at the bottom. Water could penetrate behind the casing causing damage to the home. The same door has a piece of wood below the threshold that is missing paint on both ends. I recommend that a licensed contractor be consulted to evaluate and make any necessary repairs.

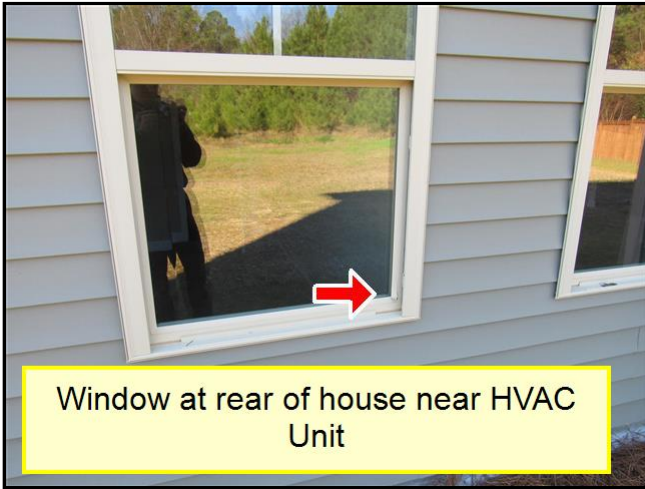
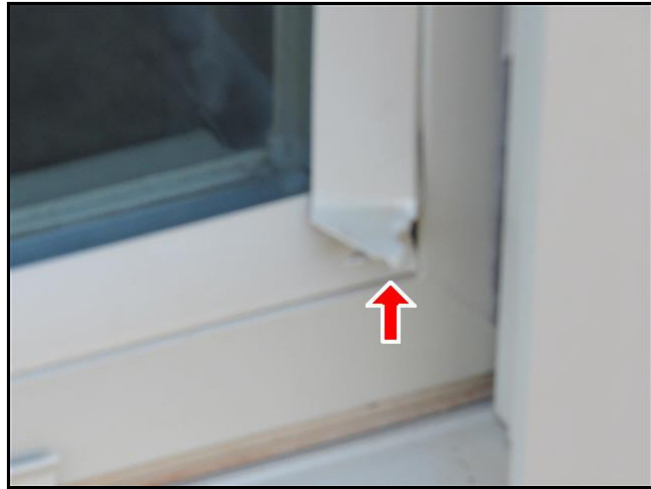
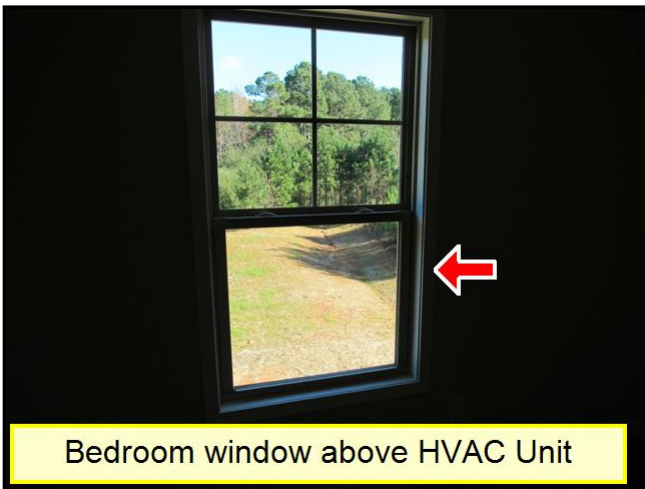
2.2 The first floor window at the rear of the house near the HVAC Unit has a piece of vinyl trim that is broken. I recommend that a licensed contactor be consulted to evaluate and make any necessary repairs.

The bedroom window (2cnd floor) above the HVAC Unit does not open or close freely. It appears that the track on the right side of the window is damaged. I recommend that a licensed contactor be consulted to evaluate and make any necessary repairs.

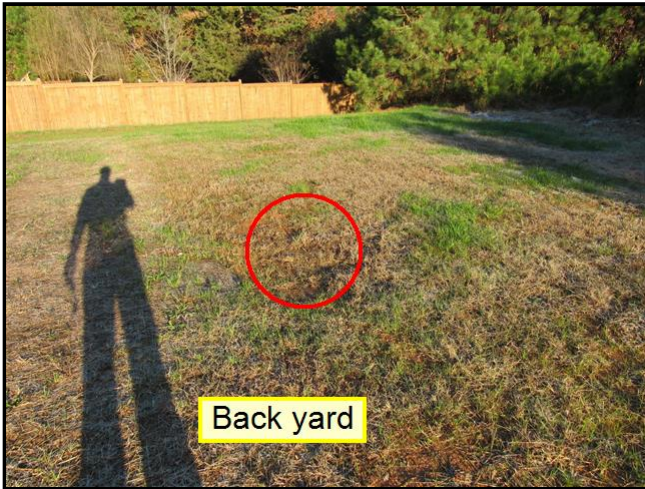
2.4 Item 1(Picture)

2.4 At the rear of the house in the grass I found a depression in the ground. It appears that the top soil has sunk in this area and could lead to ponding in the yard. The contractor should be consulted to evaluate and repair as necessary.

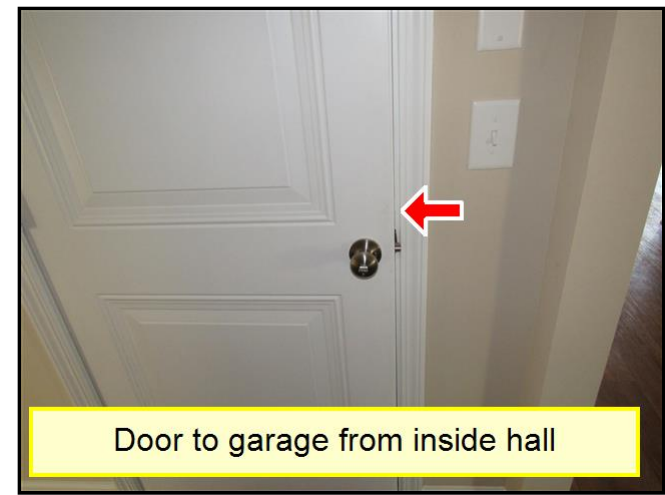
3.4 Item 1(Picture)

3.4 The door from the inside hall to the garage hits the right side of the door jamb when closing. I recommend that a licensed contractor be consulted to evaluate and make any necessary repairs.

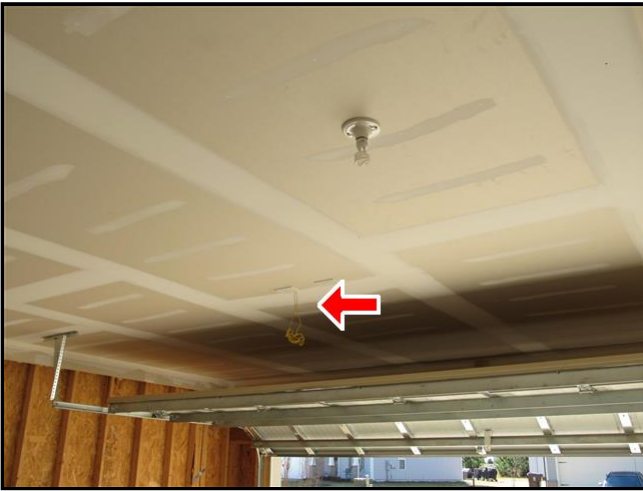
3.5 Item 1(Picture)

3.5 At the time of the inspection an automatic door opener was not present, however the wiring was located in the ceiling and by the door for an opener to be installed. Once the automatic door opener is installed I recommend that it be tested for automatic reverse when met with resistance.

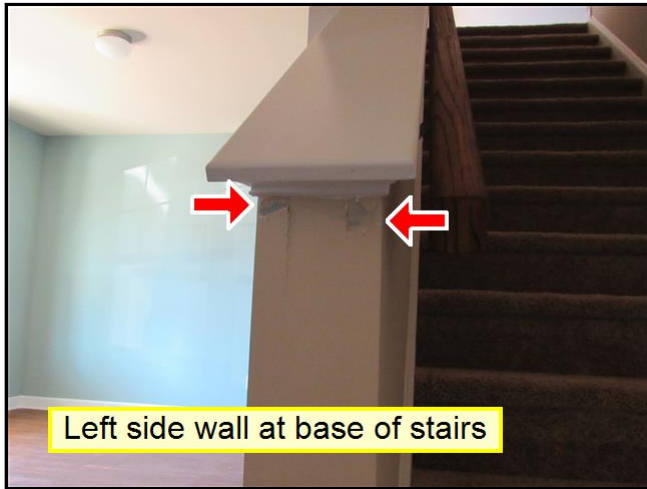
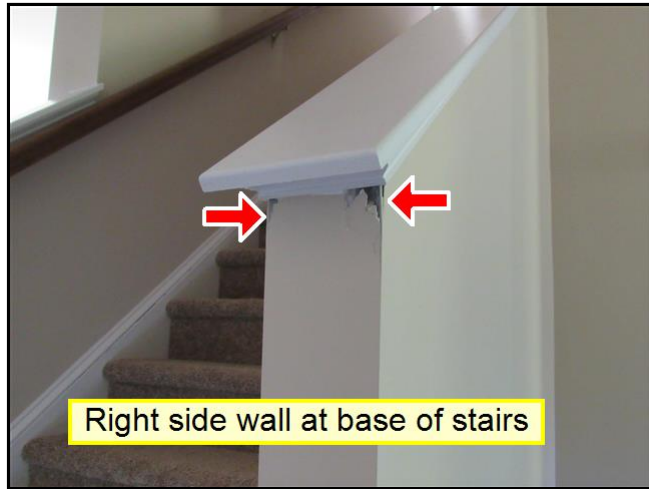
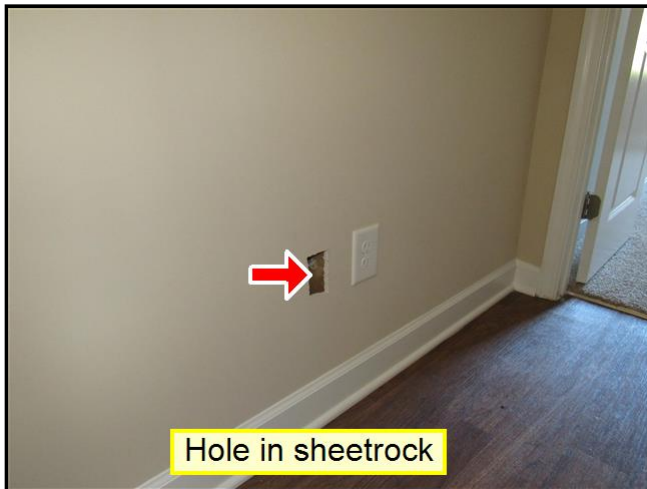
4.1 The left and right side wall at the base of the stairs has sheetrock that is missing. This is a cosmetic issue.

The hallway wall near the garage door has a hole in the sheetrock next to the receptacle. A contractor should be consulted to evaluate and make necessary repairs.

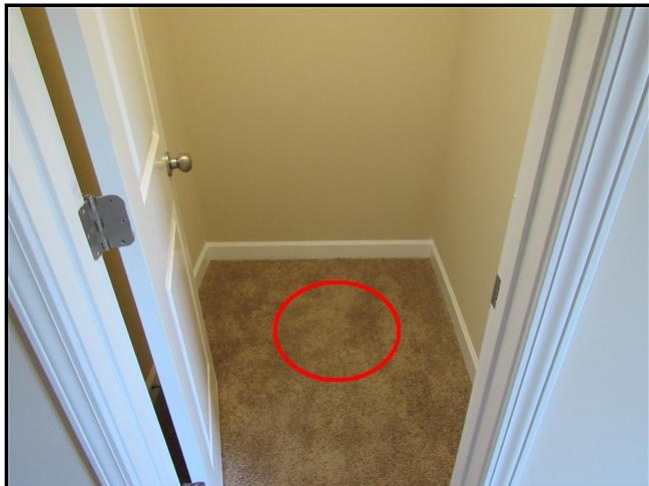
4.2 Item 1(Picture)

4.2 The bedroom at the right rear of the house has loose subfloor in the closet. When I walked over the area it made a noise and I could feel it move under my feet. This is a cosmetic issue.

The bedroom that is above the HVAC unit has loose subflooring in an area near the closet. This is a cosmetic issue.

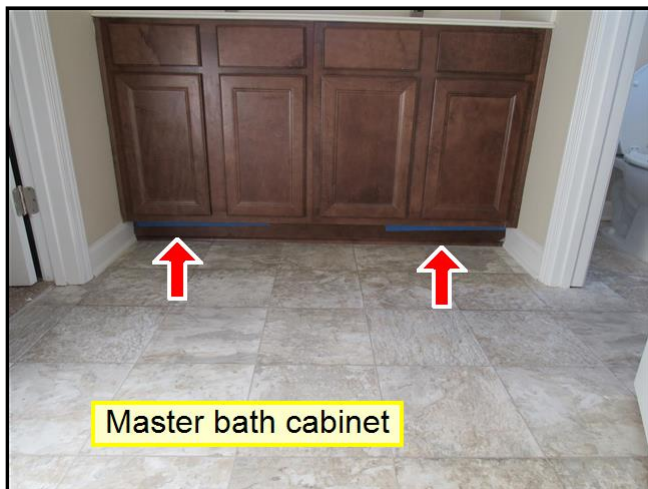
4.4 Item 1(Picture)

4.4 The cabinet in the master bath has blue tape on the kick board. This is a cosmetic issue.

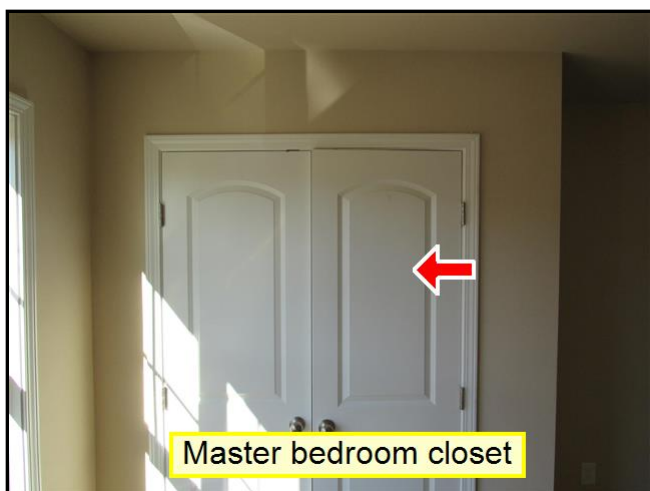
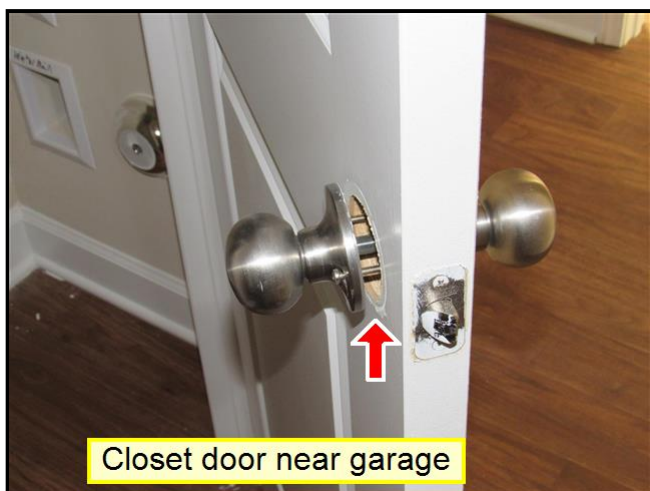
4.5 The right side master bedroom closet door will not stay closed. I recommend that a contractor evaluate and repair as necessary.

The closet door near the kitchen is missing a door knob and strike plate. I recommend that a contractor evaluate and repair as necessary.

The closet door near the garage has a loose door knob. I recommend that a contractor evaluate and repair as necessary.

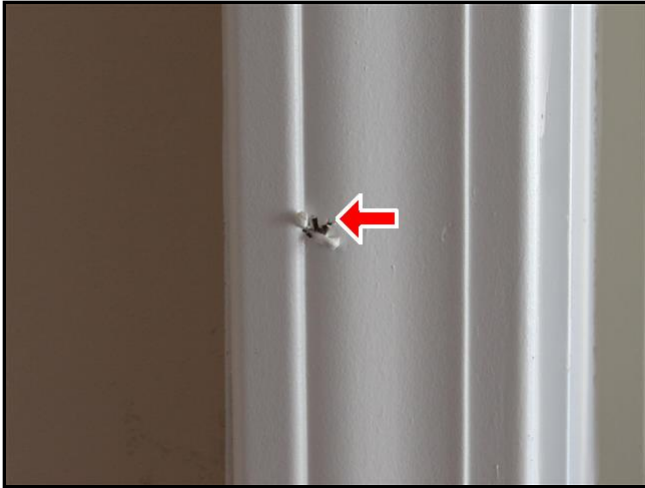
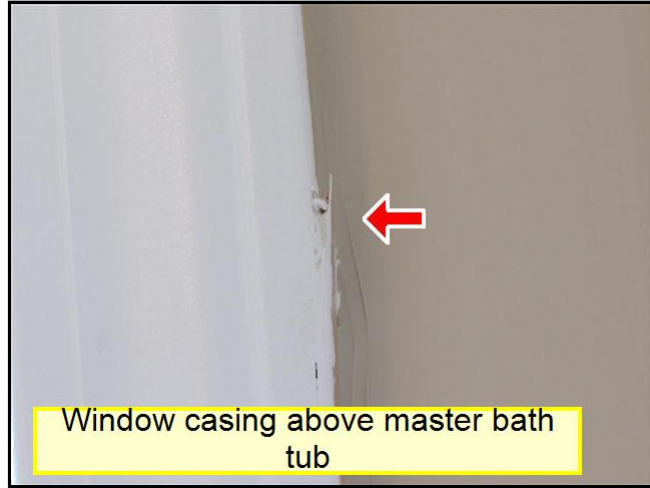
4.6 The master bedroom window on the left side has a nail protruding. This is a safety hazard and needs to be corrected. I recommend that a contractor evaluate and repair as necessary.

The window casing above the master bath tub has splintered wood on the side. This could cause someone to be injured if they grab onto the casing. I recommend that the contractor be consulted to evaluate and make any necessary repairs.

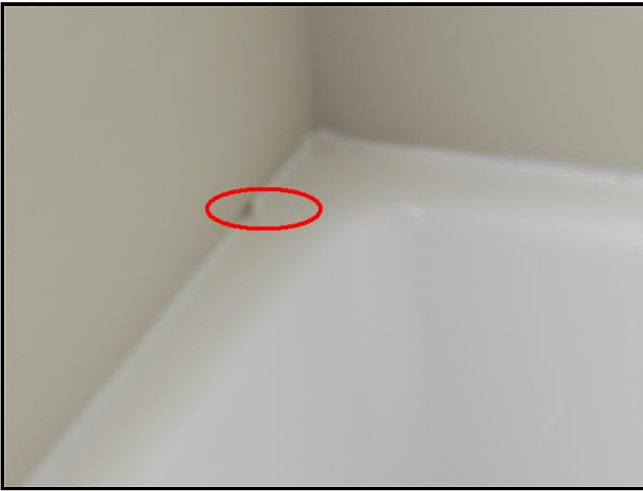
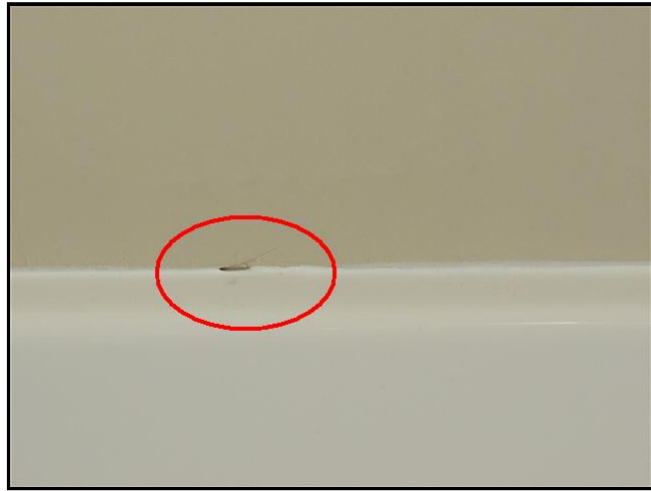
6.1 In the master bathroom where the tub meets the wall two areas have small holes in the caulk. This could lead to water penetration behind the wall and cause damage to the framing. I recommend that the contractor be consulted to evaluate and make any necessary repairs.

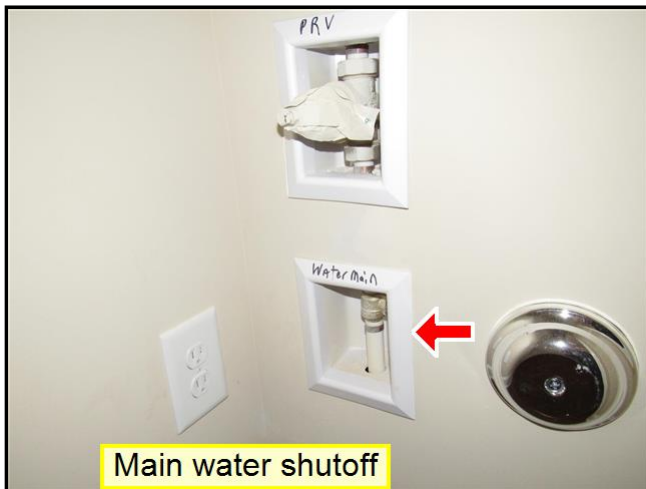
6.3 Item 1(Picture)

6.3 The main water shutoff for the house is located inside the closet in the hall near the garage door. This is for your information.

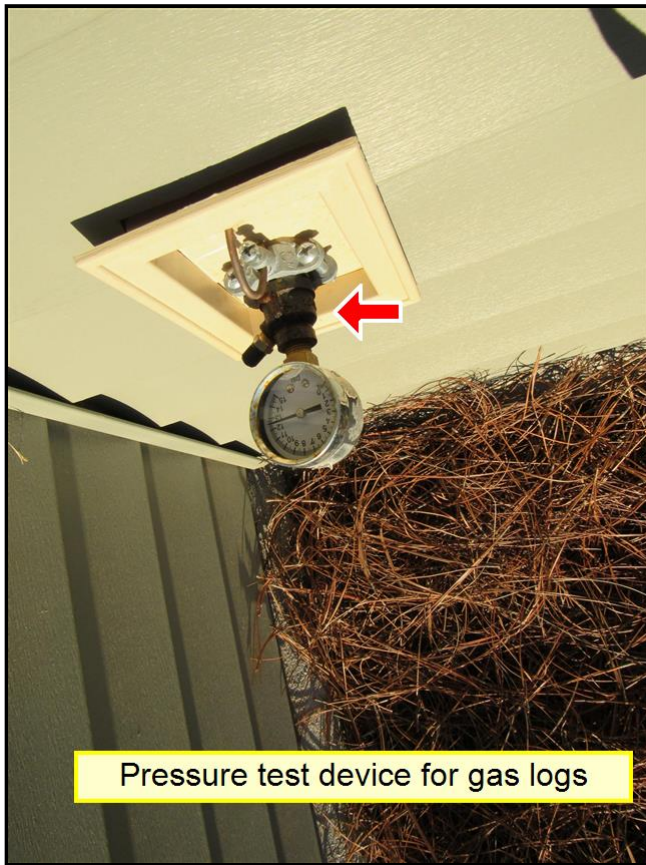
6.5 Item 1(Picture)

6.5 The fire place has gas logs installed, however a gas source was not installed at the time of inspection. A pressure test device was attached to the piping for the gas logs at the outside rear of the house on the right side of the fireplace.

Pressure test device for gas logs

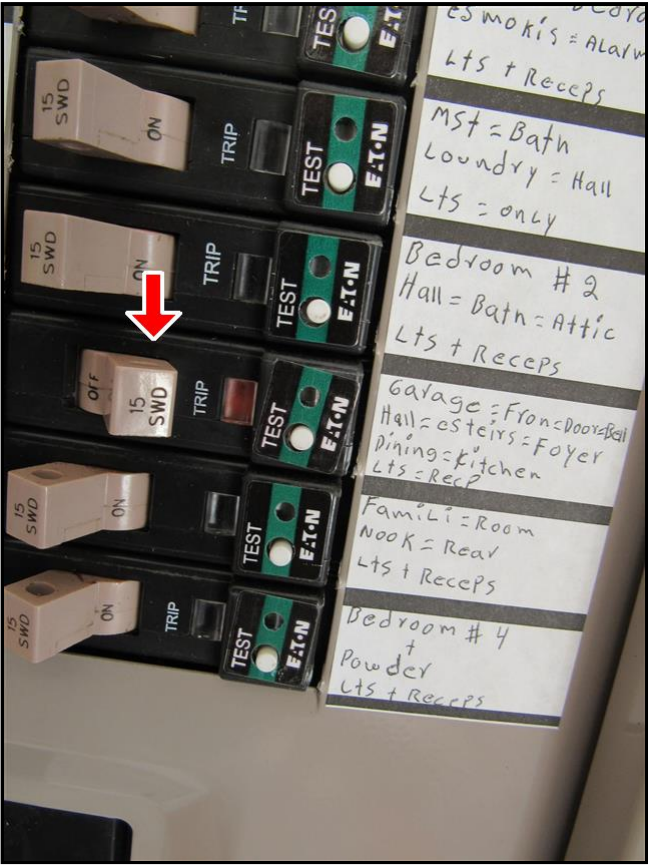
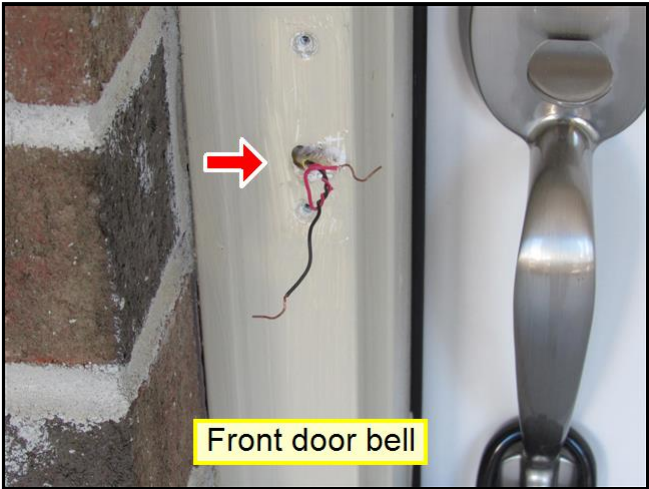
7.3 Several lights and outlets in the kitchen, garage, hall near garage, outside front door light and foyer area were not working at the time of the inspection. The circuit breaker marked garage, hall etc. was in the off position. The contractor was unable to come to the home and turn the breaker on. I recommend that a licensed electrician be consulted to evaluate the system and make necessary repairs.

The front door bell is missing and low voltage wires are exposed at the front door casing. I recommend that the contractor be consulted to evaluate and make any necessary repairs.

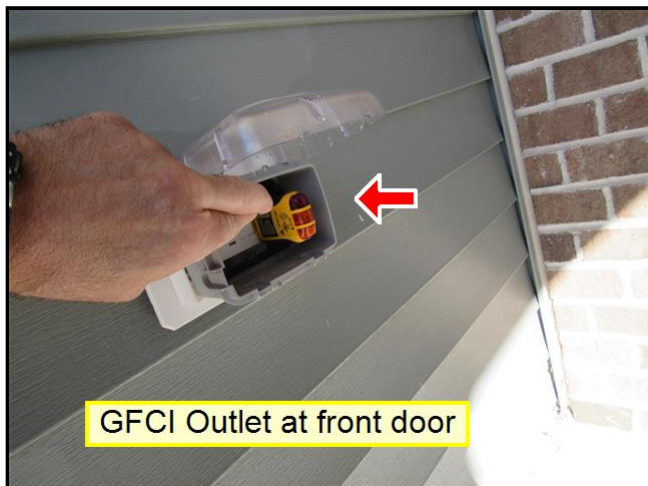
7.5 Item 1(Picture)

7.5 The GFCI outlet at the front outside door was not working at the time of the inspection. This may be the same circuit attached to the circuit breaker that would not reset. I recommend that a licensed electrician be consulted to evaluate and make any necessary repairs.

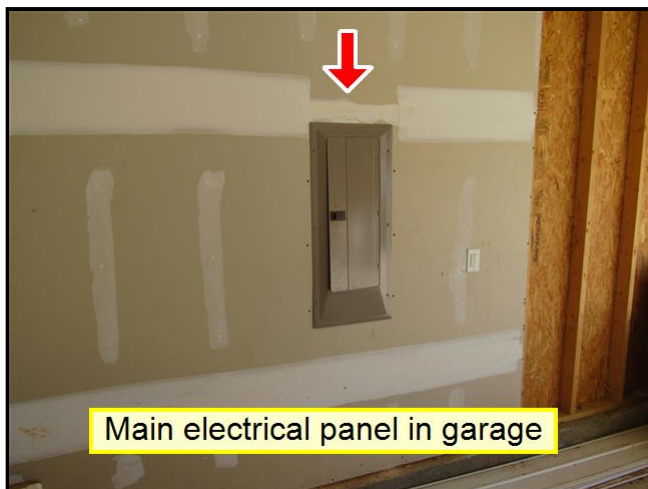
7.6 Item 1(Picture)

7.6 The main electrical panel is located in the garage on the right side wall. This is for informational purposes.

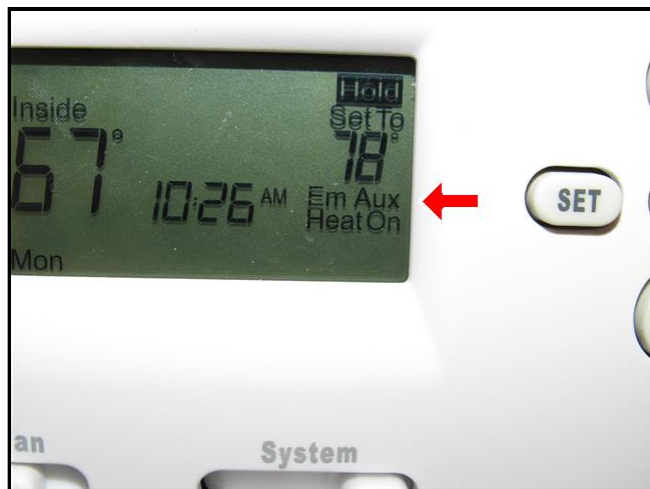
8.0 Item 1(Picture)

8.0 The heat pump worked as intended in the normal heating cycle, however when I turned both thermostats to Emergency Heat it would not increase the heated air as is normal for this cycle. I recommend that a licensed HVAC contractor be consulted to evaluate and make any necessary repairs.

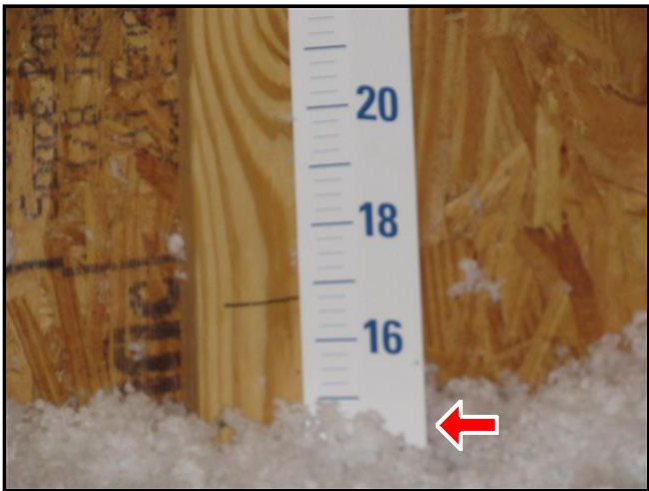
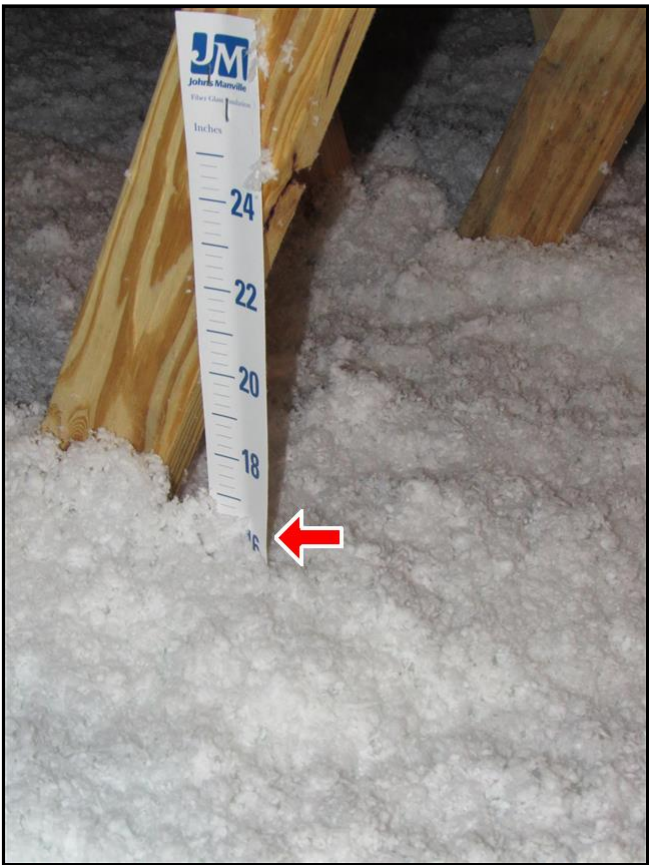
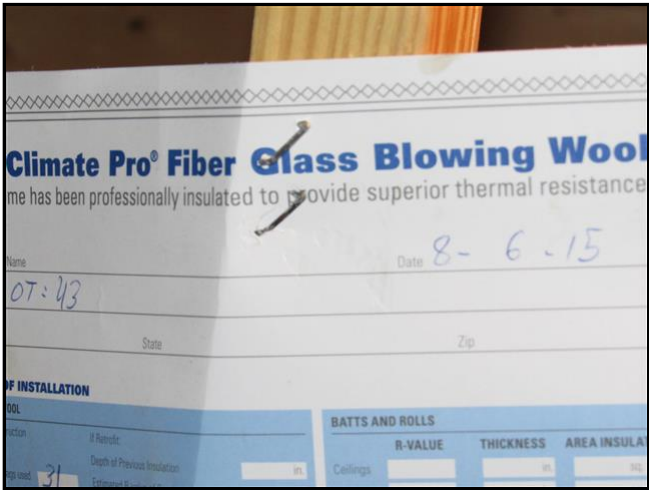
9.0 The insulation in the attic is 15 inches of Fiber glass blown wool.

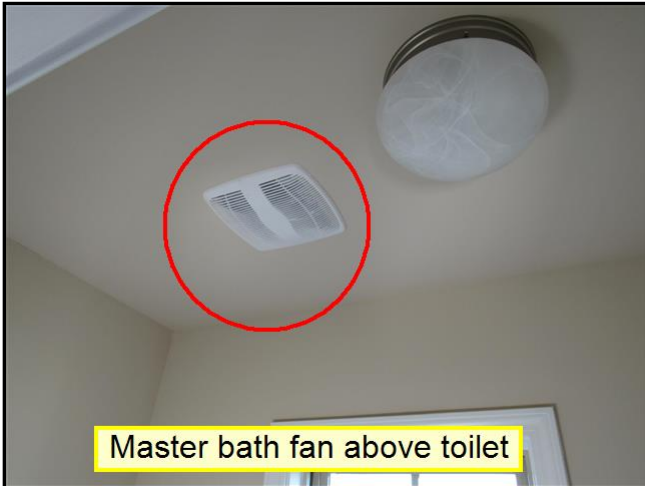
9.4 Item 1(Picture)

9.4 The fan in the master bathroom above the toilet made a humming noise when I turned the switch on and did not appear to draw any air. I recommend that the contractor evaluate and make any necessary repairs.

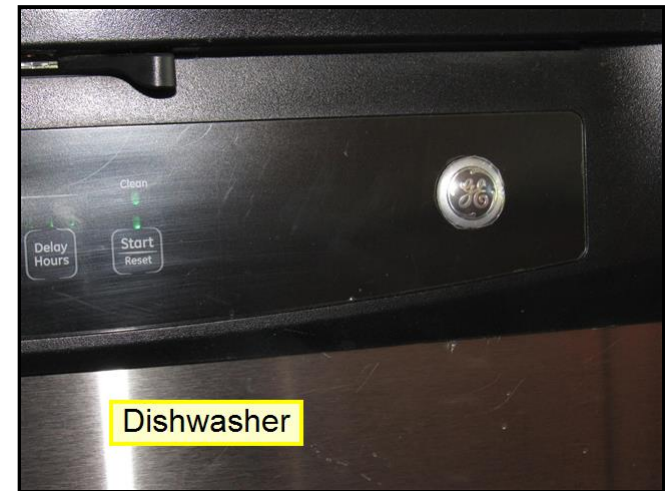
10.0 Item 1(Picture)

10.0 The dishwasher located in the kitchen near the sink was not tested during the inspection because the electrical power was off to the appliance. I recommend that the contractor be consulted to evaluate the dishwasher once the electrical power has been restored.

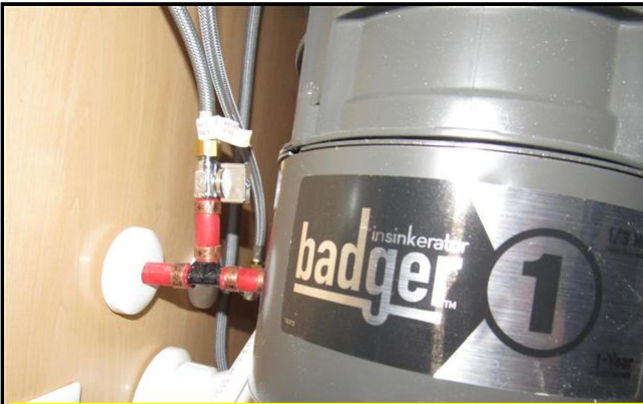
10.4 Item 1(Picture)

10.4 The garbage disposal under the kitchen sink was not tested during the inspection because the power to the appliance was off. I recommend that the contractor be consulted to evaluate the garbage disposal once the electrical power has been restored.

Garbage Disposal under kitchen sink

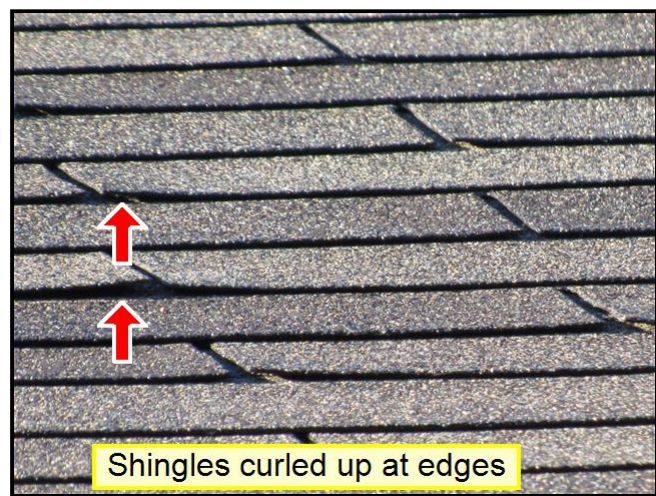
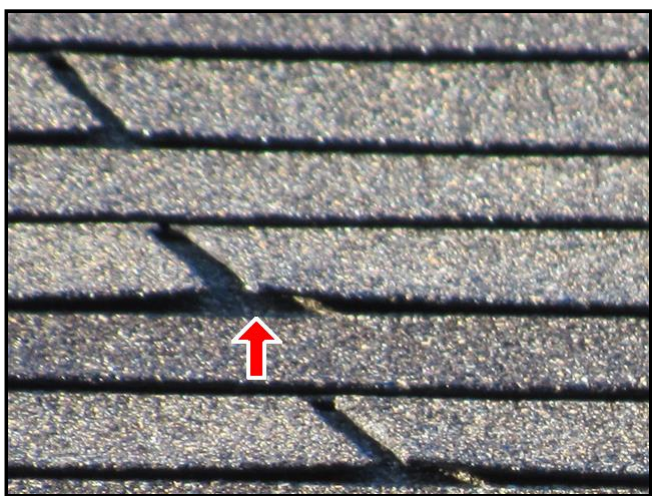
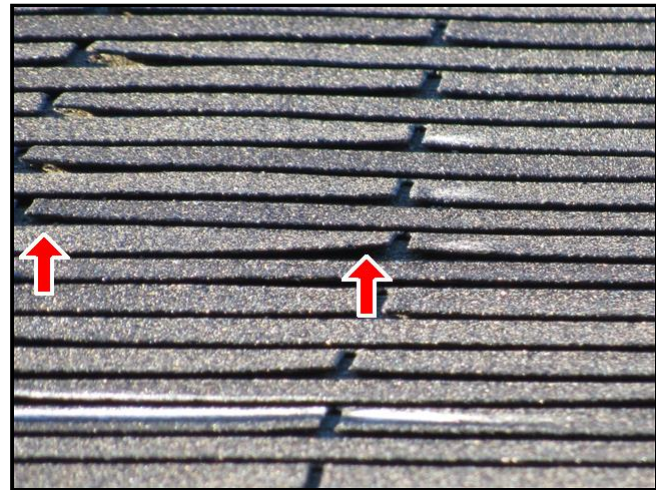
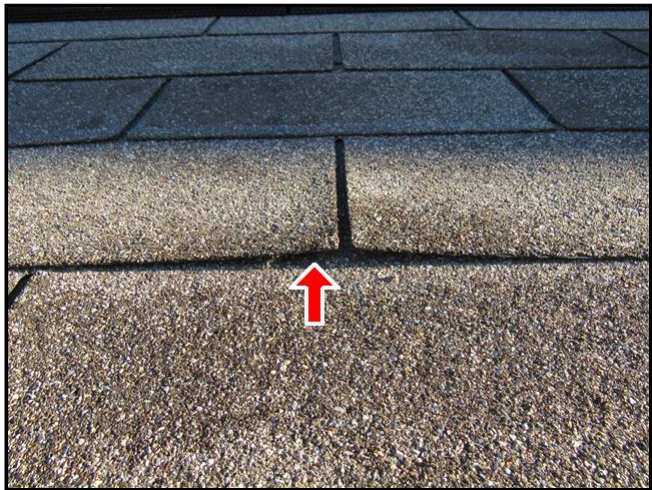
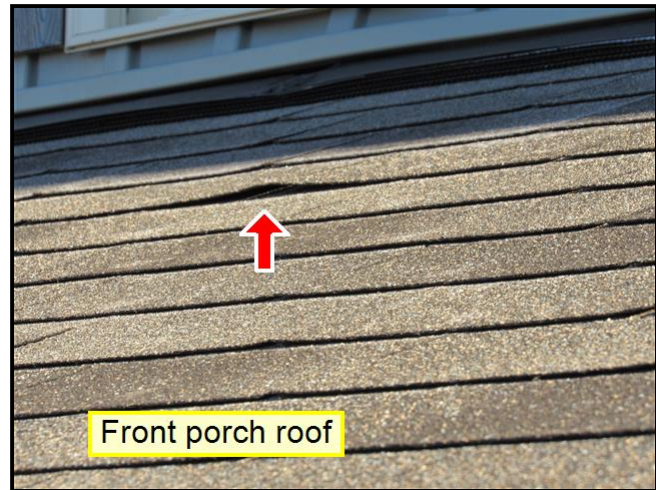
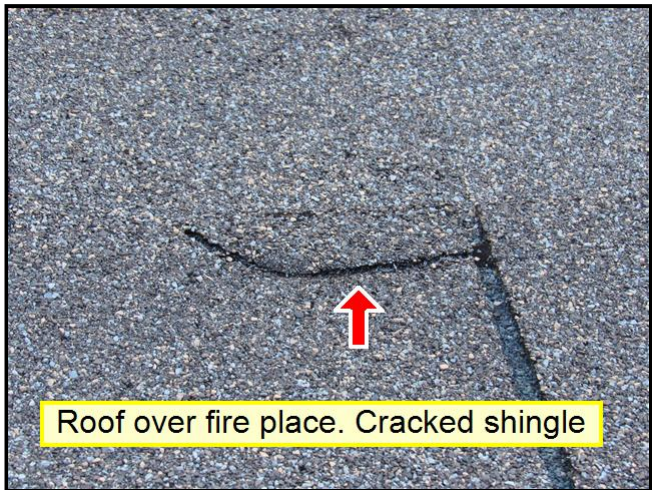
Several roof shingles on the rear of the house are curled up at the edges and are not laying flat. Also, one roof shingle on the front of the home over the porch is curled upward at the edge and not laying flat. Shingles that are curled upward can be caught in high winds possibly causing water penetration into the home and shingles to tear off. I recommend that a licensed contractor evaluate the roof and make any necessary repairs.

The roof over the fire place at the rear of the house has a cracked shingle. The shingle appears to have been cemented in place, however I recommend that a licensed contractor evaluate the roof and make any necessary repairs.

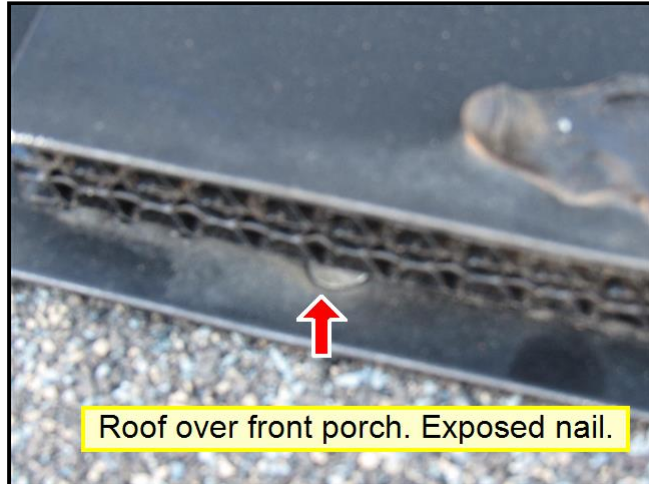
1.1 Item 1(Picture)

The roof over the front porch has an exposed nail over the counter flashing and near roof vent. Water could penetrate the roof at the nail causing damage to the home. I recommend that a licensed contractor evaluate the roof and make any necessary repairs.

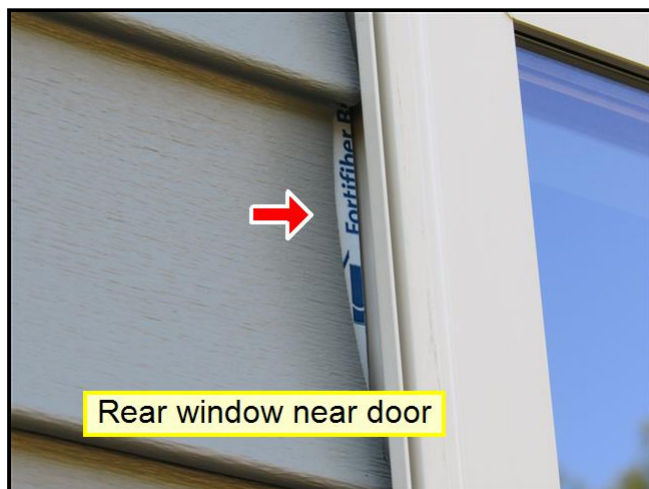
2.0 Item 1(Picture)

The exterior wall membrane can be seen around the window near the rear door. Vinyl siding needs to have expansion space, however the membrane with writing showing may be unsightly. This is a cosmetic issue.

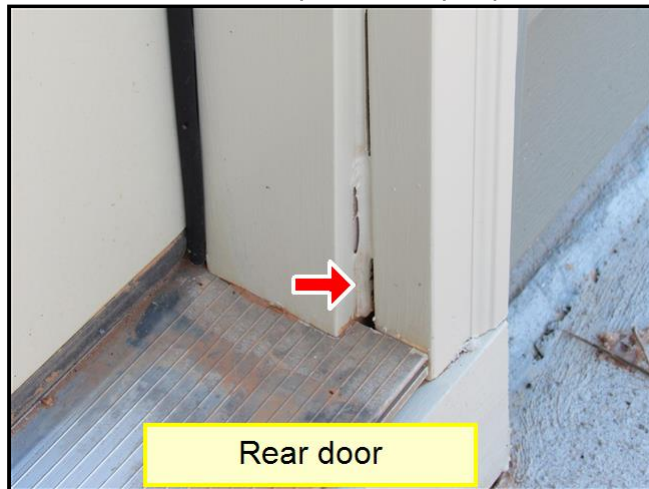
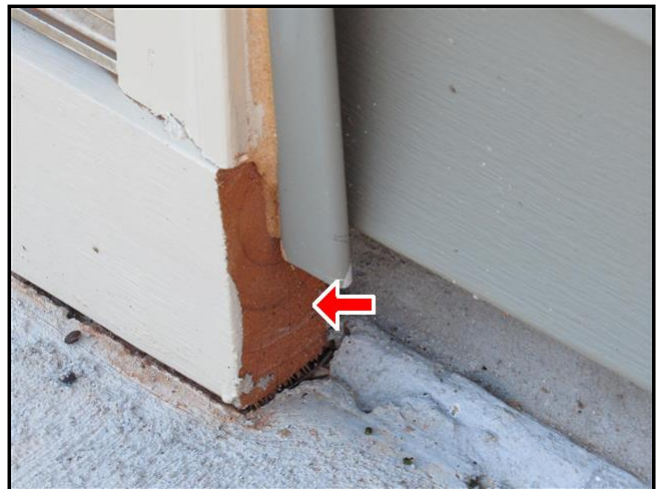
The right side casing of the rear door has a measurable gap at the bottom. Water could penetrate behind the casing causing damage to the home. The same door has a piece of wood below the threshold that is missing paint on both ends. I recommend that a licensed contractor be consulted to evaluate and make any necessary repairs.

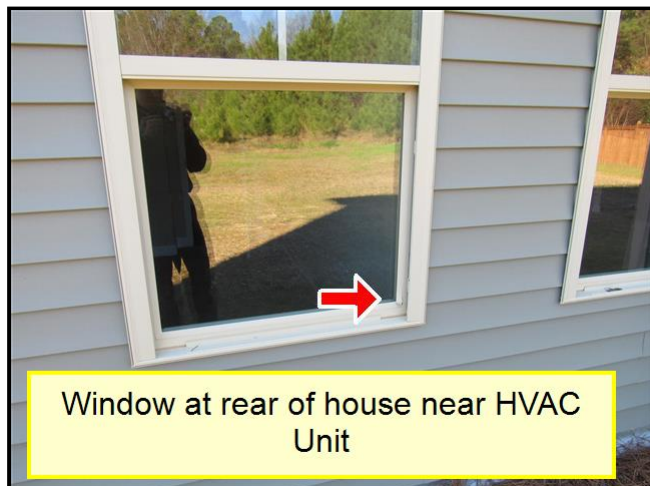
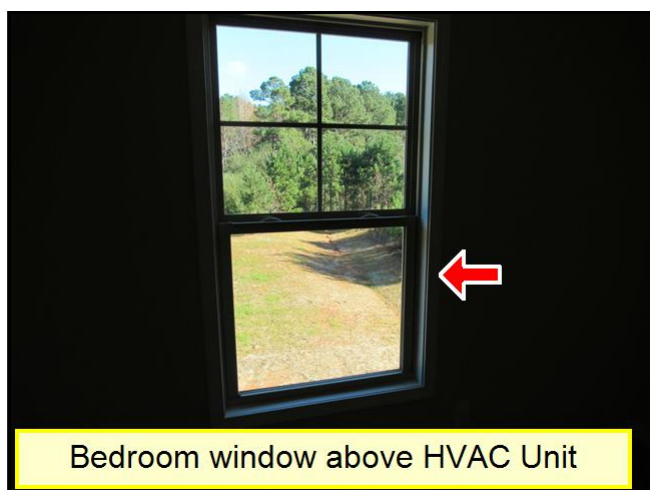
The first floor window at the rear of the house near the HVAC Unit has a piece of vinyl trim that is broken. I recommend that a licensed contractor be consulted to evaluate and make any necessary repairs.

The bedroom window (2cnd floor) above the HVAC Unit does not open or close freely. It appears that the track on the right side of the window is damaged. I recommend that a licensed contractor be consulted to evaluate and make any necessary repairs.

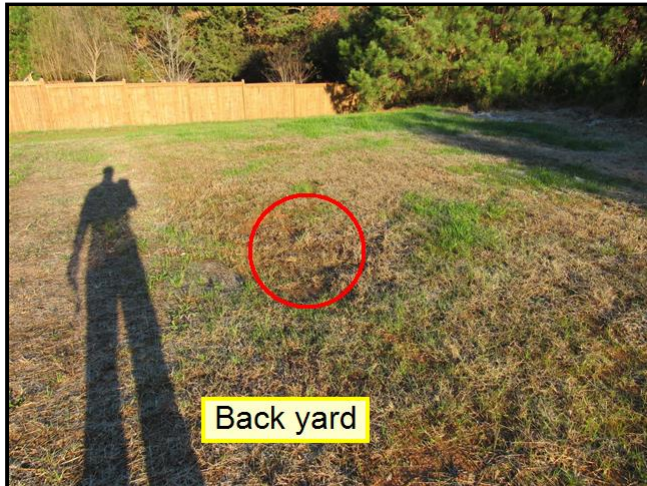
2.4 Item 1(Picture)

At the rear of the house in the grass I found a depression in the ground. It appears that the top soil has sunk in this area and could lead to ponding in the yard. The contractor should be consulted to evaluate and repair as necessary.

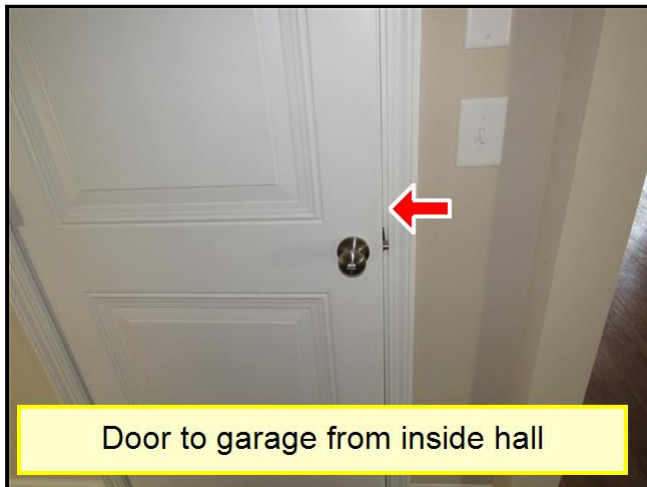
3.4 Item 1(Picture)

The door from the inside hall to the garage hits the right side of the door jamb when closing. I recommend that a licensed contractor be consulted to evaluate and make any necessary repairs.

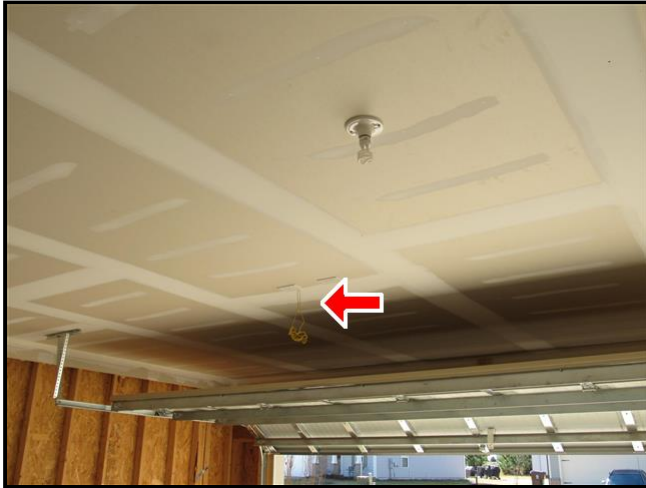
3.5 Item 1(Picture)

At the time of the inspection an automatic door opener was not present, however the wiring was located in the ceiling and by the door for an opener to be installed. Once the automatic door opener is installed I recommend that it be tested for automatic reverse when met with resistance.

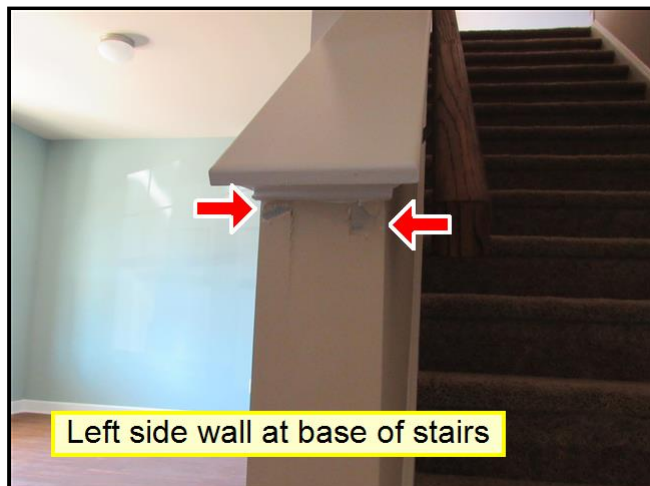
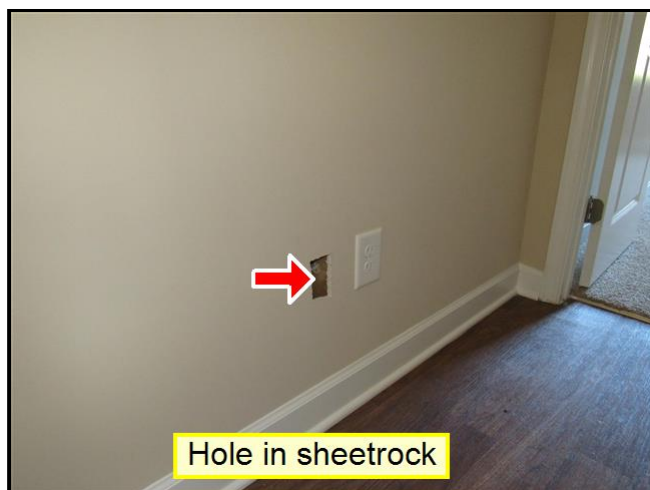
The left and right side wall at the base of the stairs has sheetrock that is missing. This is a cosmetic issue.

The hallway wall near the garage door has a hole in the sheetrock next to the receptacle. A contractor should be consulted to evaluate and make necessary repairs.

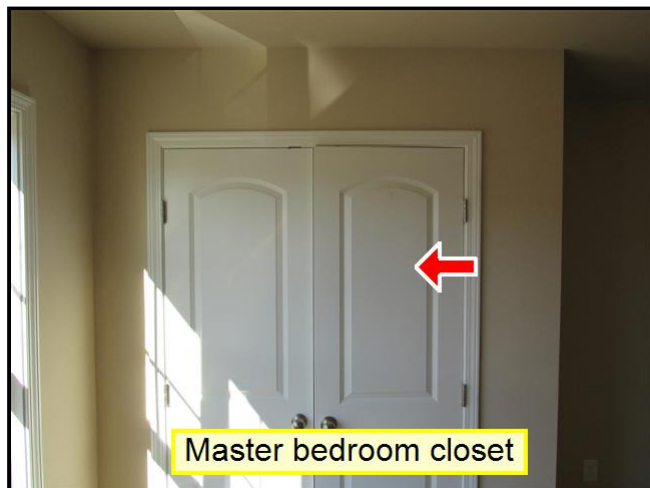
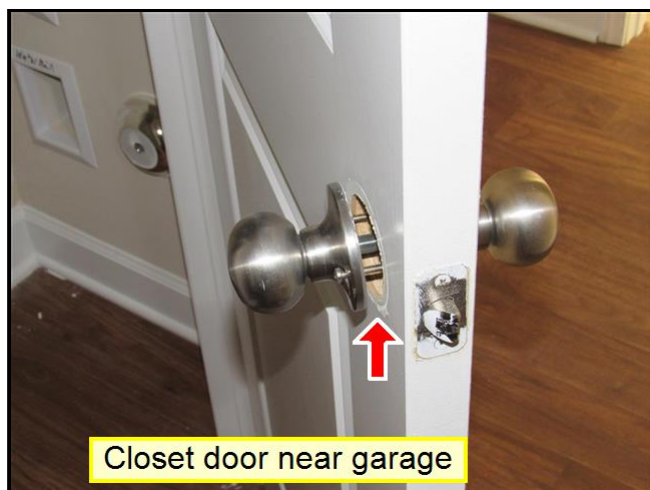
The right side master bedroom closet door will not stay closed. I recommend that a contractor evaluate and repair as necessary.

The closet door near the kitchen is missing a door knob and strike plate. I recommend that a contractor evaluate and repair as necessary.

The closet door near the garage has a loose door knob. I recommend that a contractor evaluate and repair as necessary.

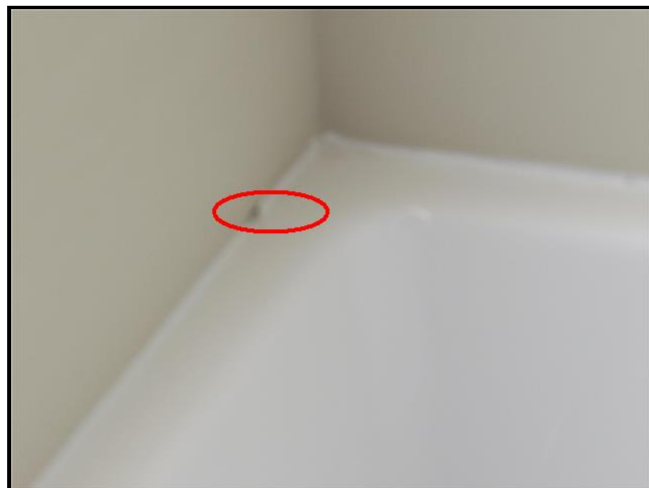
6.1 Item 1(Picture)

In the master bathroom where the tub meets the wall two areas have small holes in the caulk. This could lead to water penetration behind the wall and cause damage to the framing. I recommend that the contractor be consulted to evaluate and make any necessary repairs.
