Inspection Report

3001 University Place
New City NC 56789

Stephen and Son Home Inspection Services, LLC

Date: 1/16/2014	Time: 08:00 AM	Report ID: Sample New Home
Property: 3001 University Place New City NC 56789	Customer: Frank and Joan Smith	Real Estate Professional:

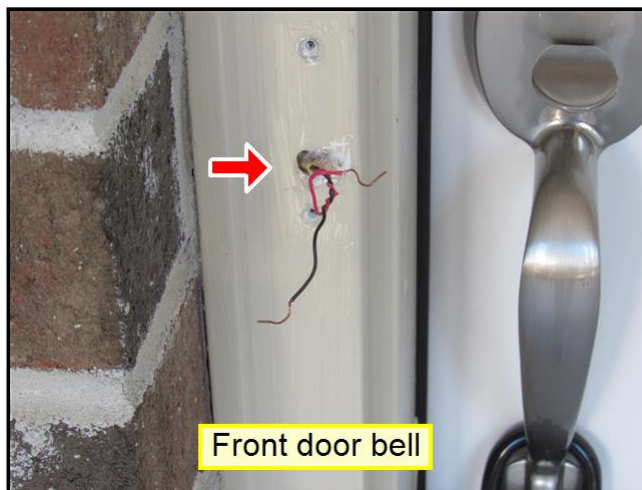
The front door bell is missing and low voltage wires are exposed at the front door casing. I recommend that the contractor be consulted to evaluate and make any necessary repairs.

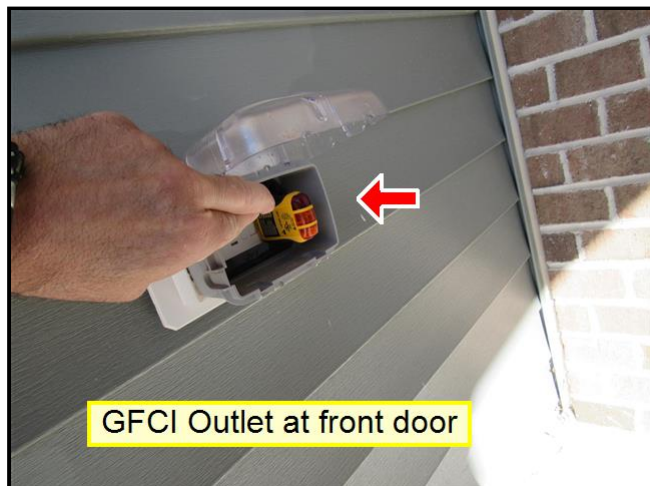
7.5 Item 1(Picture)

7.5 The GFCI outlet at the front outside door was not working at the time of the inspection. This may be the same circuit attached to the circuit breaker that would not reset. I recommend that a licensed electrician be consulted to evaluate and make any necessary repairs.

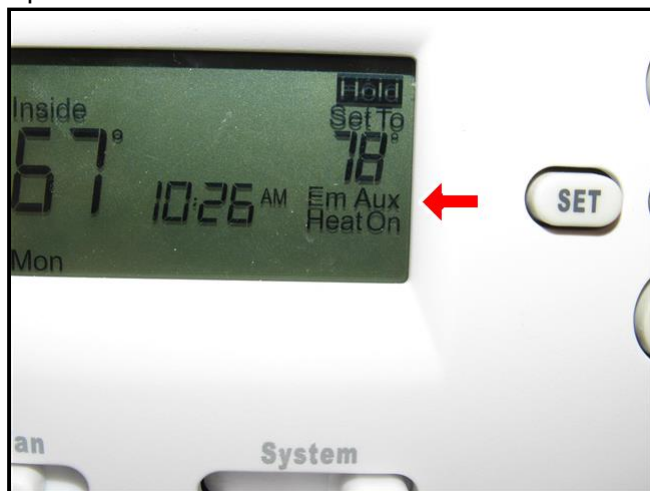
8.0 Item 1(Picture)

The heat pump worked as intended in the normal heating cycle, however when I turned both thermostats to Emergency Heat it would not increase the heated air as is normal for this cycle. I recommend that a licensed HVAC contractor be consulted to evaluate and make any necessary repairs.

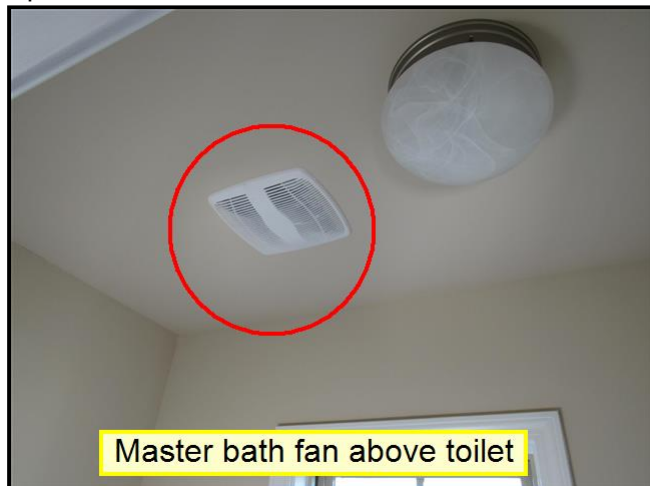
9.4 Item 1(Picture)

The fan in the master bathroom above the toilet made a humming noise when I turned the switch on and did not appear to draw any air. I recommend that the contractor evaluate and make any necessary repairs.

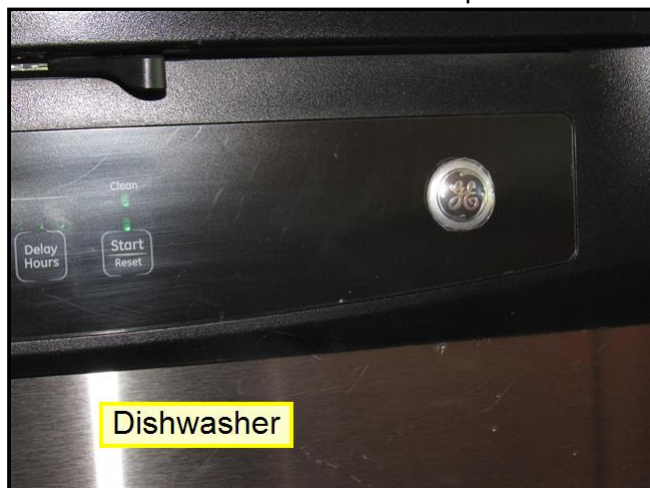
10.0 Item 1(Picture)

The dishwasher located in the kitchen near the sink was not tested during the inspection because the electrical power was off to the appliance. I recommend that the contractor be consulted to evaluate the dishwasher once the electrical power has been restored.

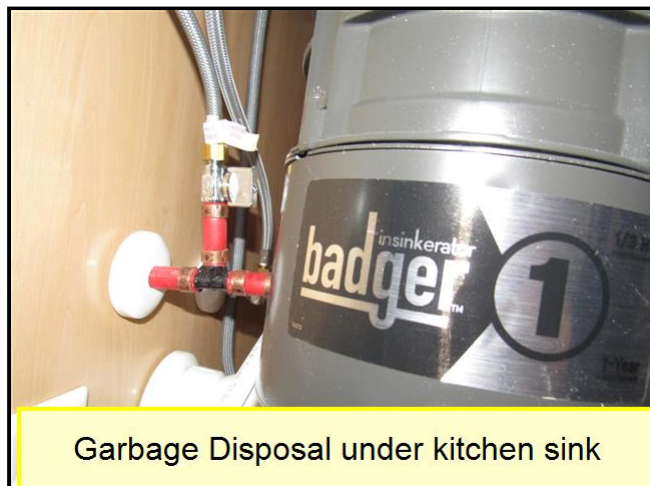
Garbage Disposal under kitchen sink
