Inspection Report

5690 Anywhere Drive
Milton NC 27893

Stephen and Son Home Inspection Services, LLC

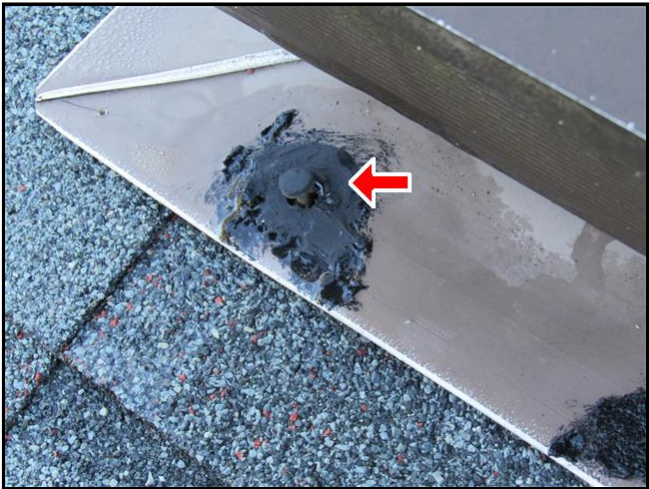
1.2 Item 2(Picture)

1.2 The roof shingles on the front of the house in between the two skylights and over the kitchen have roof cement dripped on the shingles. There is also a large amount of roof cement around the skylights. This is indicative of a roofing repair for a possible leak. Also, I found a nail popped up on one of the skylight flashings. I recommend a qualified roofer inspect the skylight penetrations, determine if leaks are present, and make any necessary repairs.

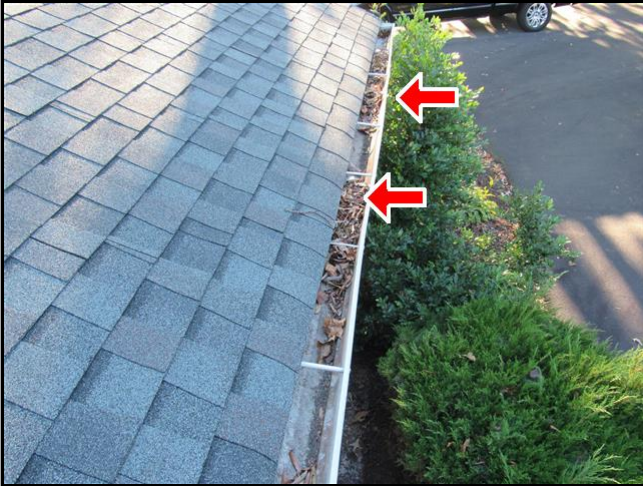
1.3 Item 1(Picture)

1.3 Some of the gutters have leaves inside which may prevent the the proper flow of water leaving the roof. I recommend having the gutters cleaned in order to provide for proper drainage.

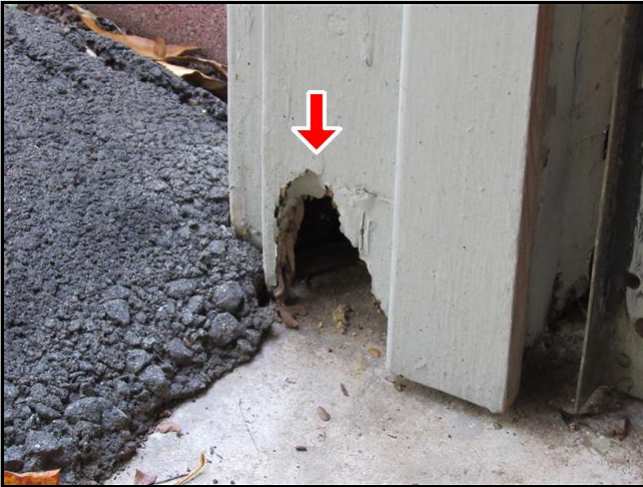
2.0 Item 1(Picture)

2.0 The wood trim on the left side of the garage door is rotted at the bottom. The hole in the bottom can lead to pest infestation. Also, the wood trim on the right side of the door is off the ground several inches. It is common practice to maintain distance between the wood and the ground to prevent water from wicking and future rot, however in this case it is such a large hole that pests could enter the garage. I recommend a qualified contractor inspect and make any necessary repairs.

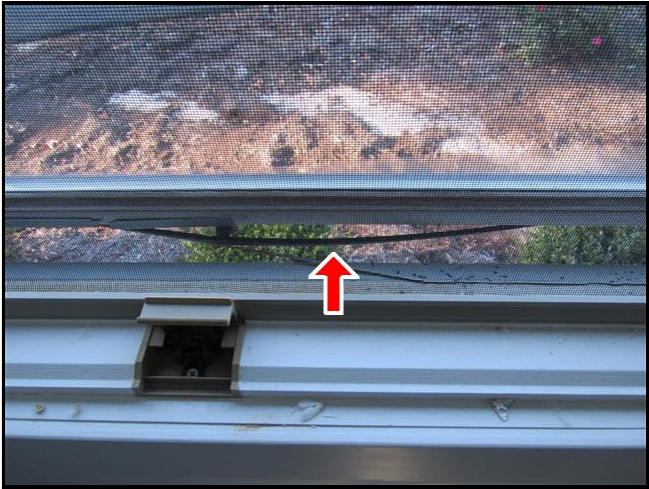
2.2 Item 2(Picture)

2.2 The casement window gasket is broken in the bedroom at the front of the house on the left side and the screen will not close. Also, the casement window on the front bedroom on the left side has a gasket that is broken. The gasket prevents water and air penetration into the home. I recommend that a qualified contractor inspect and make any necessary repairs.

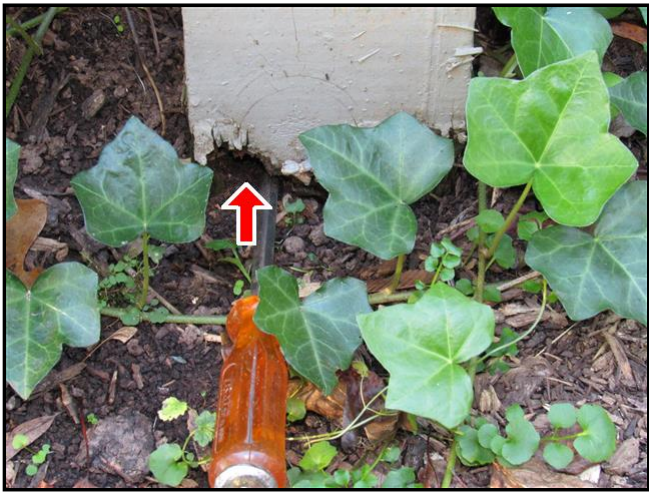
2.3 Item 3(Picture)

The 4X6 posts on the outer part of the back deck are rotted at the base where they meet the ground. The posts are holding the deck up and if they are not stable could lead to its collapse. I recommend that a licensed contractor be consulted to inspect and make any necessary repairs.

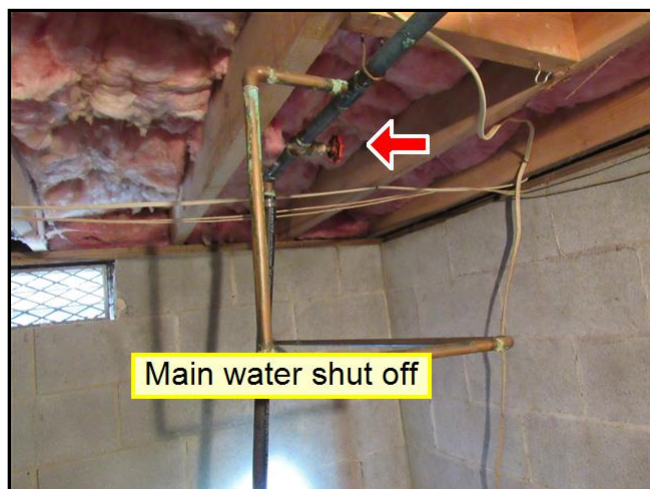
6.3 Item 1(Picture)

6.3 The main water shut off is located in the crawl space directly across from the crawl space access door from the basement. This is for informational purposes only.

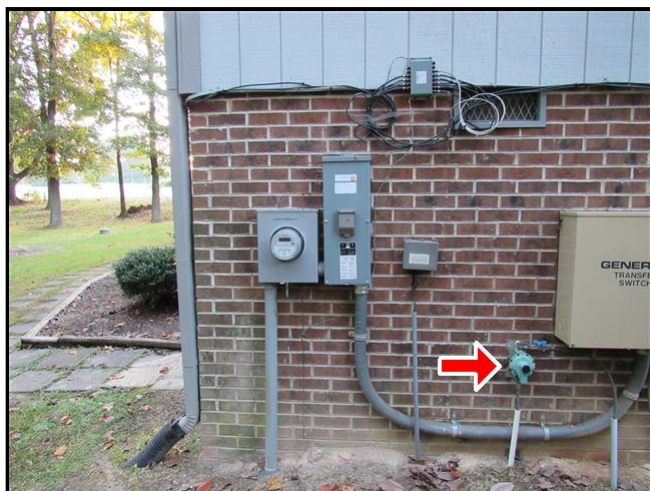
6.5 Item 1(Picture)

6.5 The main fuel shut off for the outside propane tank is located on the left side of the house near the generator and electric meter. This is for informational purposes only.

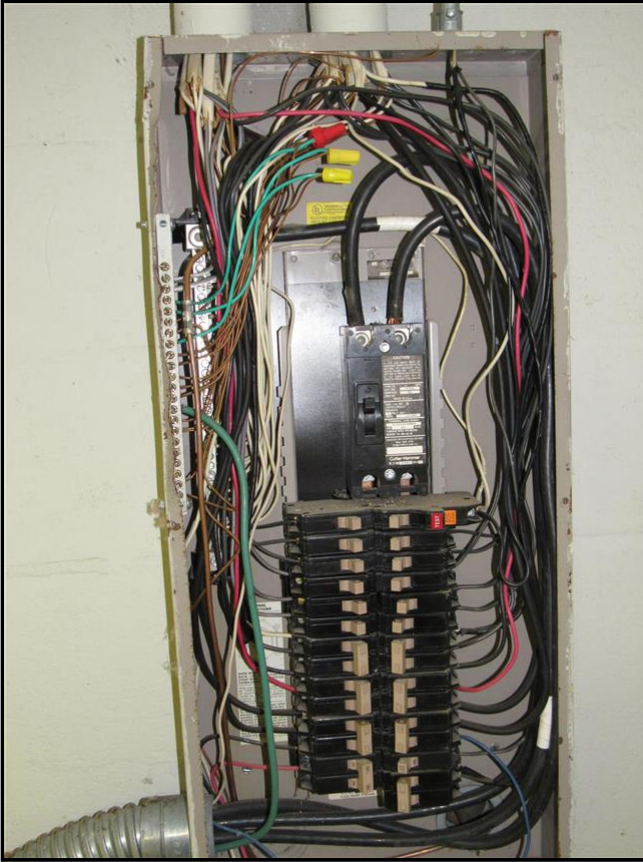
7.6 Item 1(Picture)

7.6 The main electrical panel is located in the basement on the right side wall as you enter through the door. This is for informational purposes only.

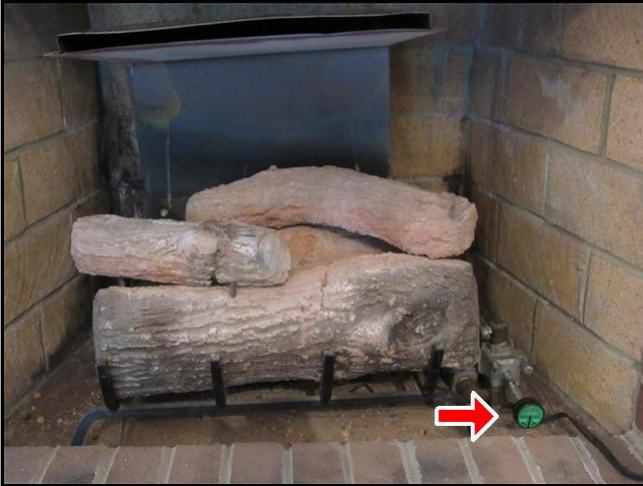
8.7 Item 1(Picture)

8.7 The pilot light for the gas logs was off during the inspection. I recommend having a qualified person service the gas logs prior to use.

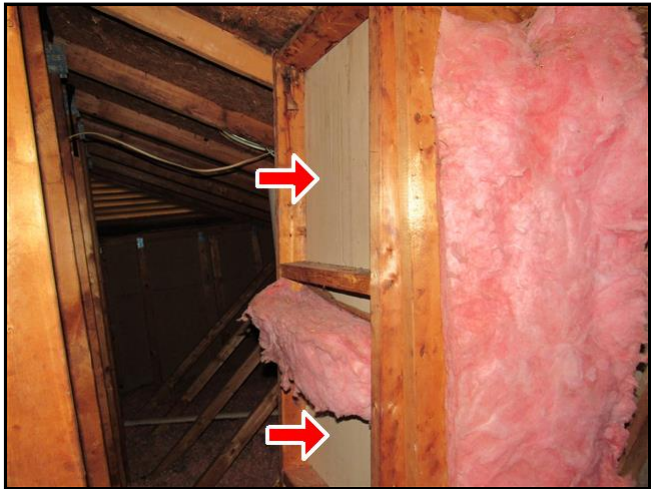
9.0 Item 2(Picture)

9.0 In the attic at the walls going up to the skylights insulation has fallen down and is missing in several areas. It is important to have insulation in areas where conditioned/heated spaces meet non conditioned/ heated spaces in order to prevent moisture. I recommend that a qualified contractor review and make necessary repairs.

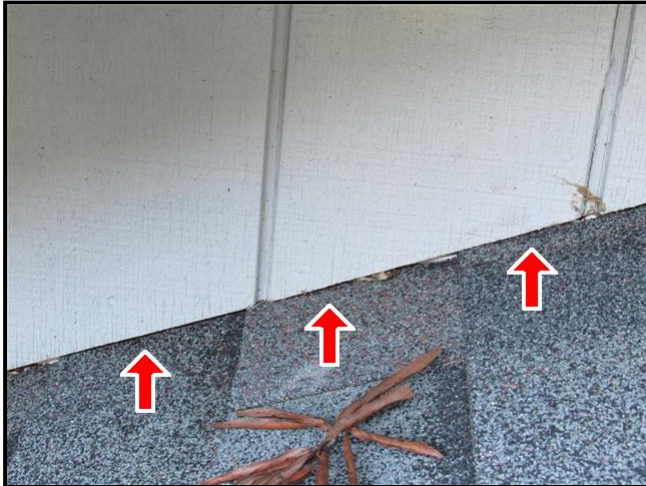
1.1 Item 1(Picture)

The siding on the left side of the house over the bedrooms touches the roof in several places. When wood siding touches the roof shingles it can wick water causing damage to the wood siding. During my inspection I did not find any of these areas where rot was present, however to prevent damage from occurring I recommend that a qualified contractor inspect and make any necessary repairs.

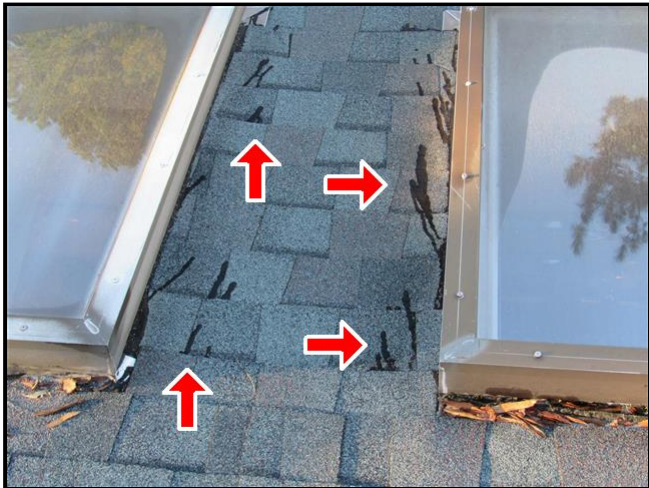
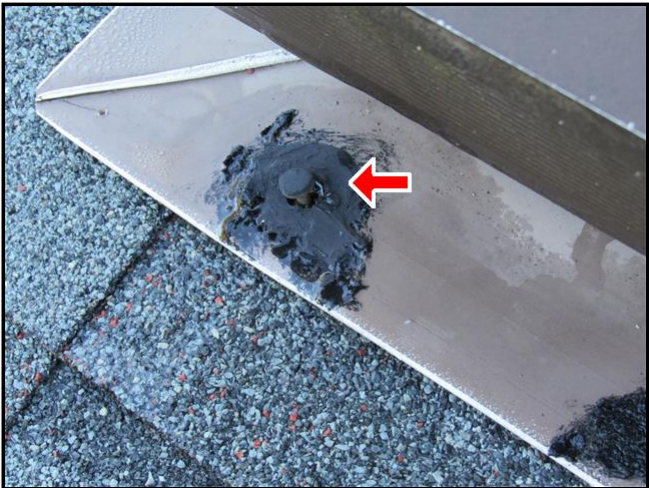
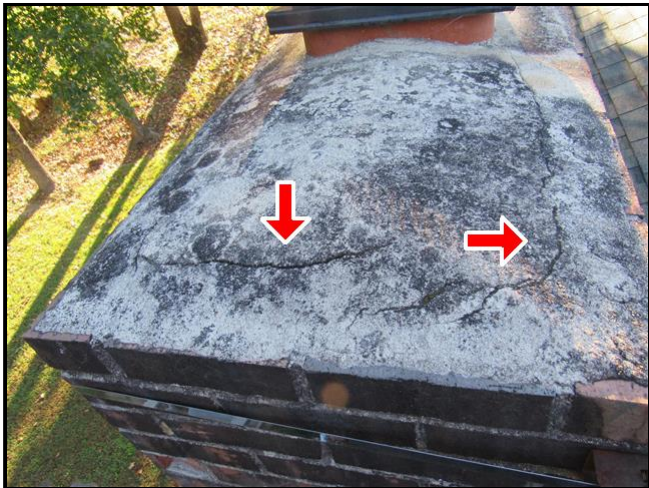
The roof shingles on the front of the house in between the two skylights and over the kitchen have roof cement dripped on the shingles. There is also a large amount of roof cement around the skylights. This is indicative of a roofing repair for a possible leak. Also, I found a nail popped up on one of the skylight flashings. I recommend a qualified roofer inspect the skylight penetrations, determine if leaks are present, and make any necessary repairs.

The top of the chimney cap has several small cracks which over time will allow water penetration and failure of the cap. I recommend a qualified mason evaluate the chimney cap and make any necessary repairs.

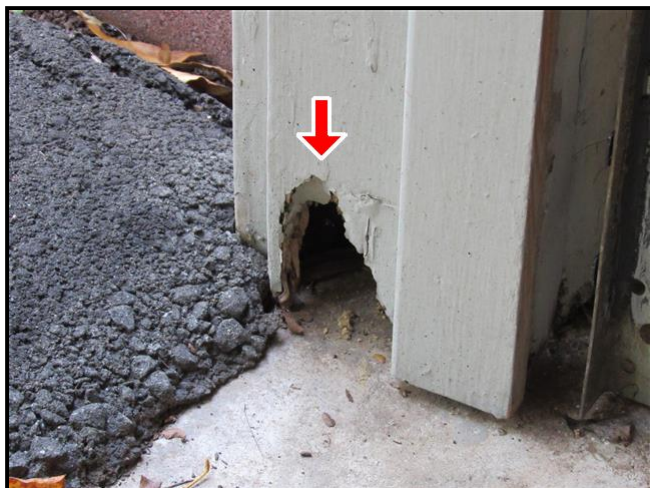
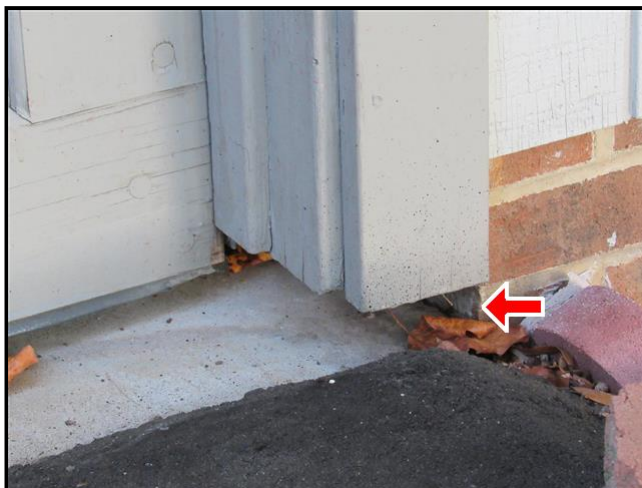
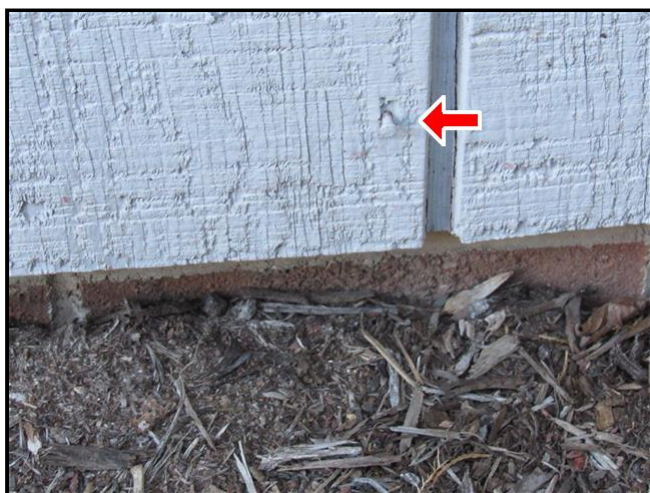
The wood trim on the left side of the garage door is rotted at the bottom. The hole in the bottom can lead to pest infestation. Also, the wood trim on the right side of the door is off the ground several inches. It is common practice to maintain distance between the wood and the ground to prevent water from wicking and future rot, however in this case it is such a large hole that pests could enter the garage. I recommend a qualified contractor inspect and make any necessary repairs.

The wood siding on the front of the house at the bottom near the garage is coming loose and popping out. A nail can be seen popped out from the siding. I recommend a qualified contractor inspect and make any necessary repairs.

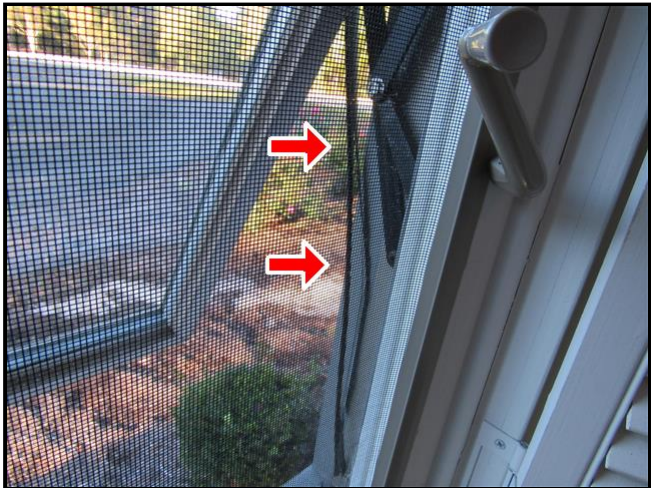
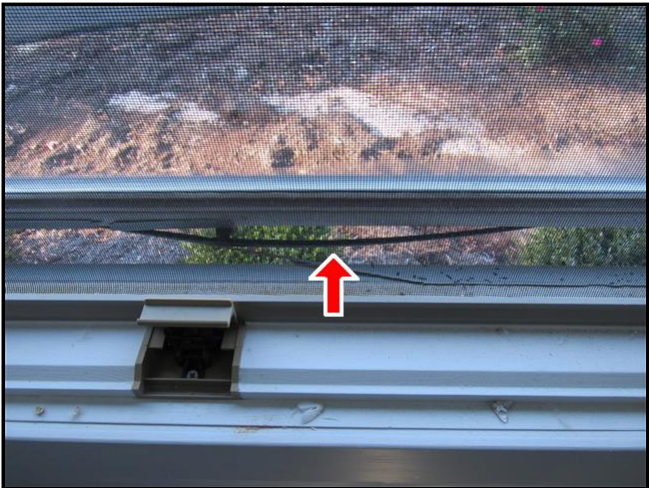
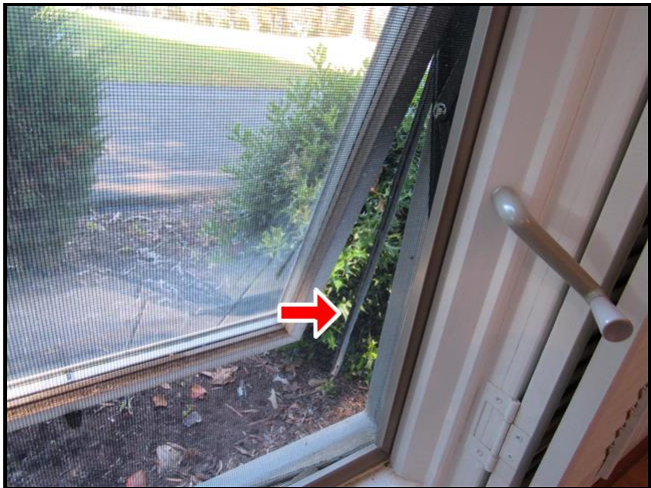
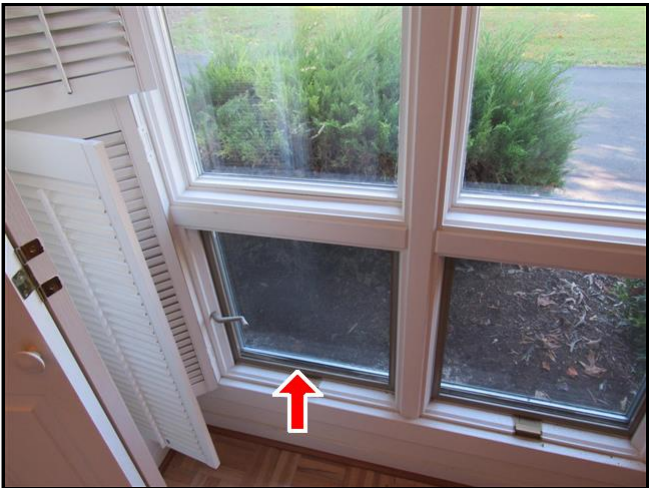
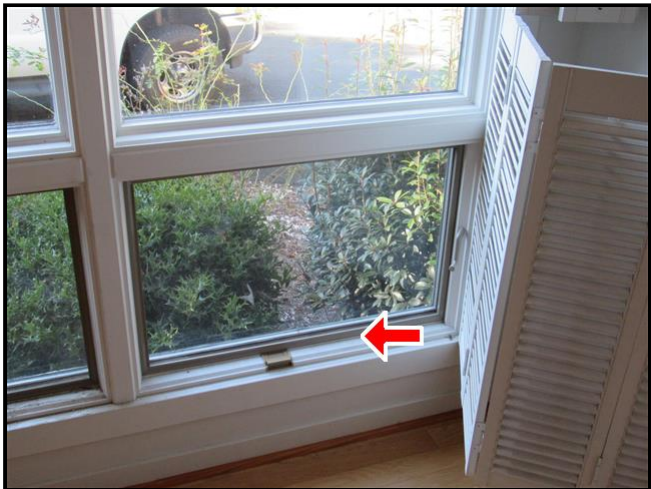
The casement window gasket is broken in the bedroom at the front of the house on the left side and the screen will not close. Also, the casement window on the front bedroom on the left side has a

gasket that is broken. The gasket prevents water and air penetration into the home. I recommend that a qualified contractor inspect and make any necessary repairs.

The right side window in the Dinette area off the kitchen and the kitchen windows near the laundry room will not open. I recommend that a qualified contractor inspect and make any necessary repairs.

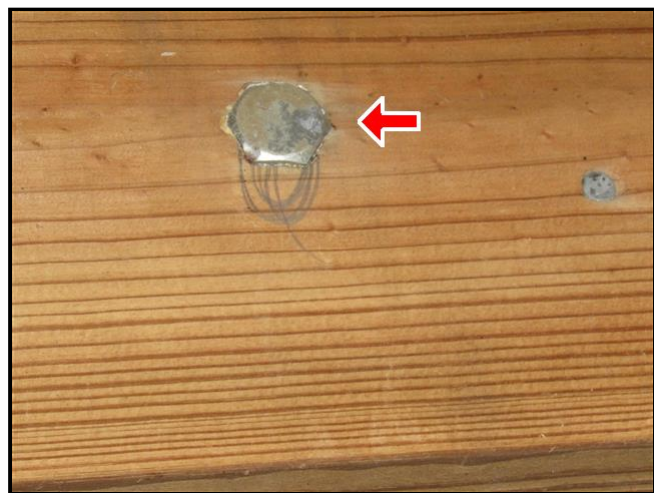
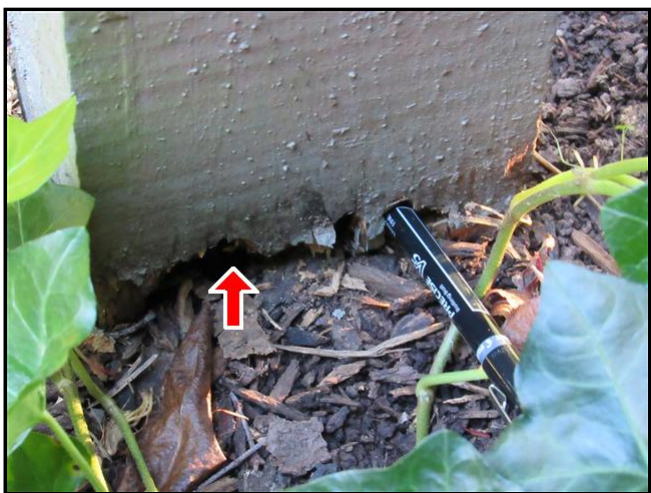
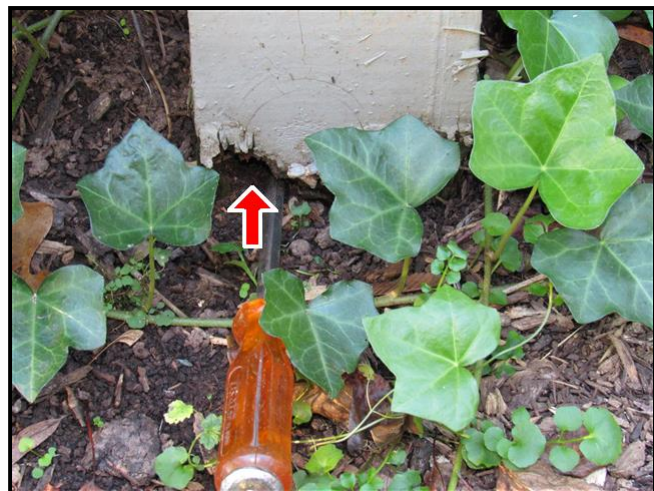
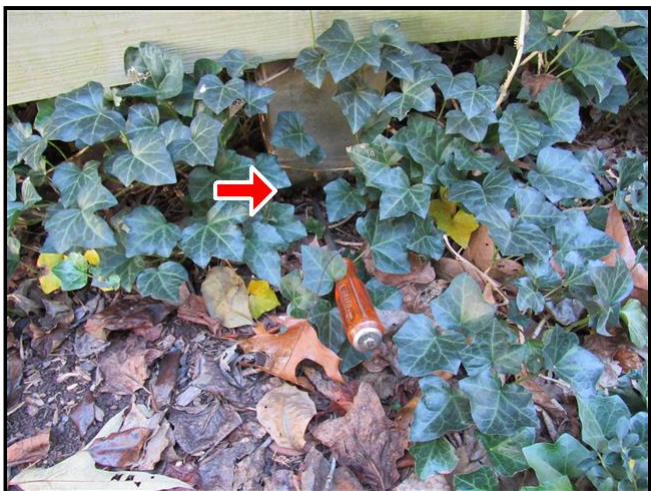
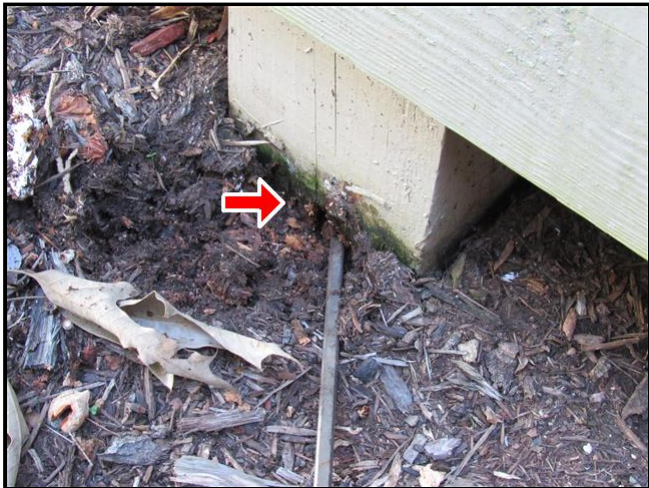
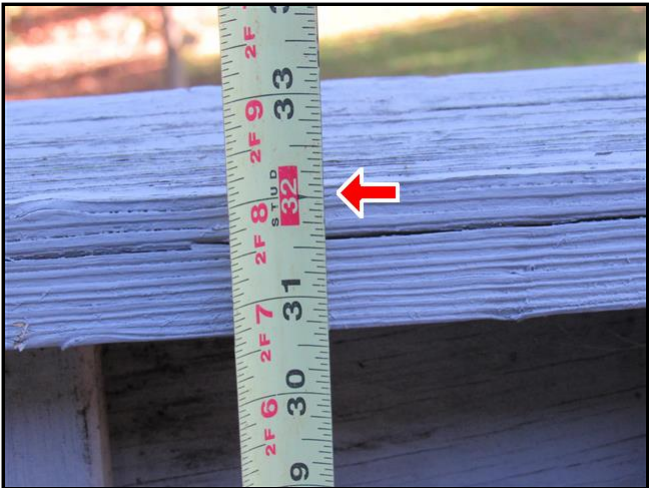
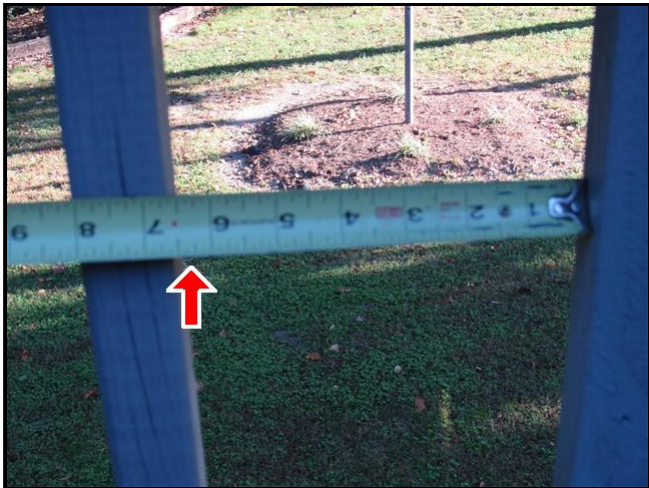
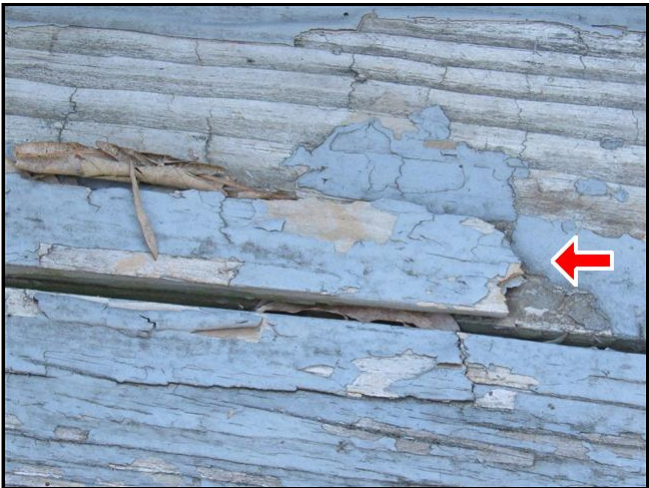
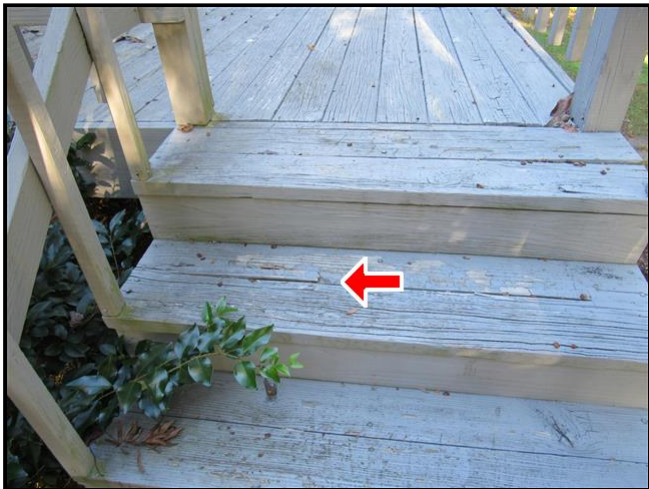
prevent bolt penetration into the wood. I recommend that a licensed contractor be consulted to inspect and make any necessary repairs.

The 4X6 posts on the outer part of the back deck are rotted at the base where they meet the ground. The posts are holding the deck up and if they are not stable could lead to its collapse. I recommend that a licensed contractor be consulted to inspect and make any necessary repairs.

The railing around the deck is 32 inches high. Also, the balusters going around the railing are apart 6.5 inches. Railings are normally 36 inches high to prevent someone from falling off the deck. Also, balusters are normally no wider than 4 inches apart to prevent a small child from going through. For safety purposes I recommend that a licensed contractor inspect and make any necessary repairs.

The top stair tread to the deck is rotted and splintering. This could lead to the failure of the tread. I recommend that a licensed contractor be consulted to inspect and make any necessary repairs.

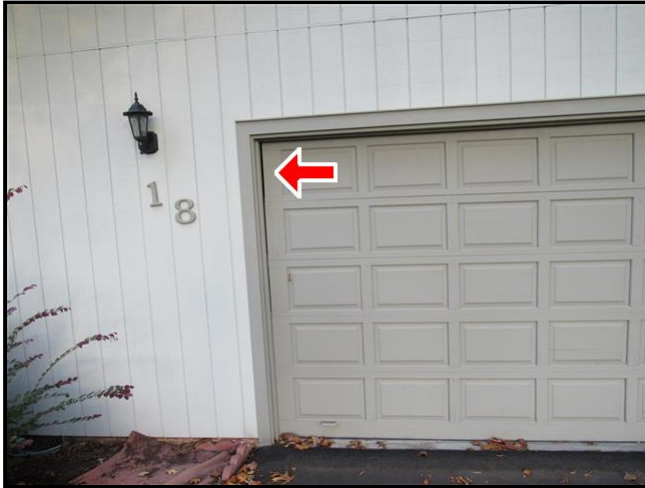
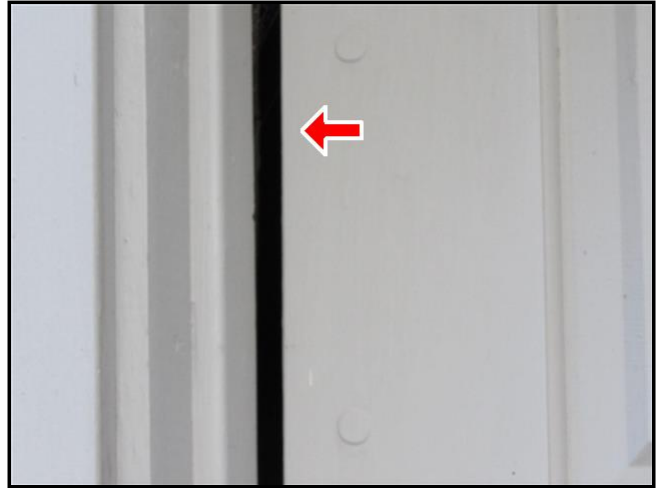
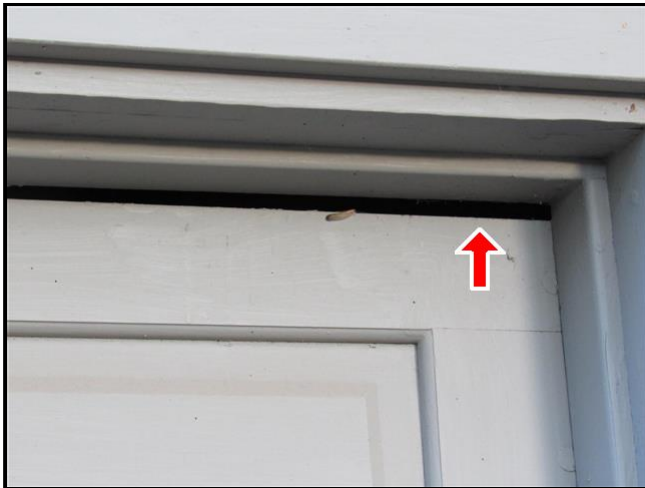
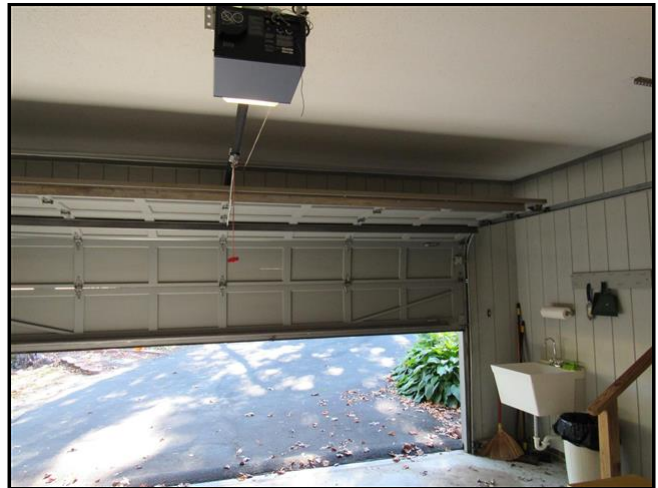
The garage door has a large space on the left side between the door and trim as well as a large space on the right side at the top between the door and trim. A screw is missing from one of the inside braces holding the door. The door appears to be out of square. When I tried to operate the automatic door opener it would only raise the door half way and then it stopped. A qualified garage door contractor should be consulted to inspect and make any necessary repairs.

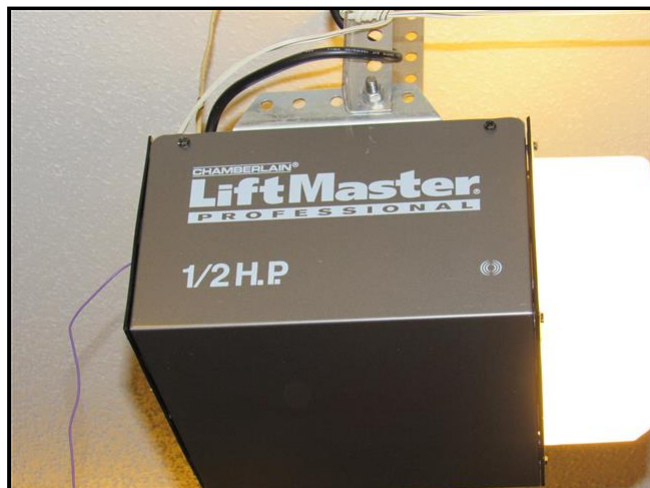
3.5 Item 1(Picture)

Once the garage door is repaired a qualified garage door contractor should inspect the door opener for proper operation.

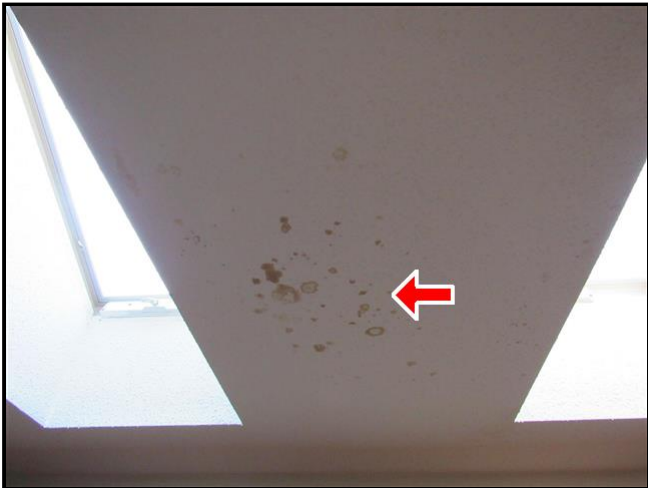
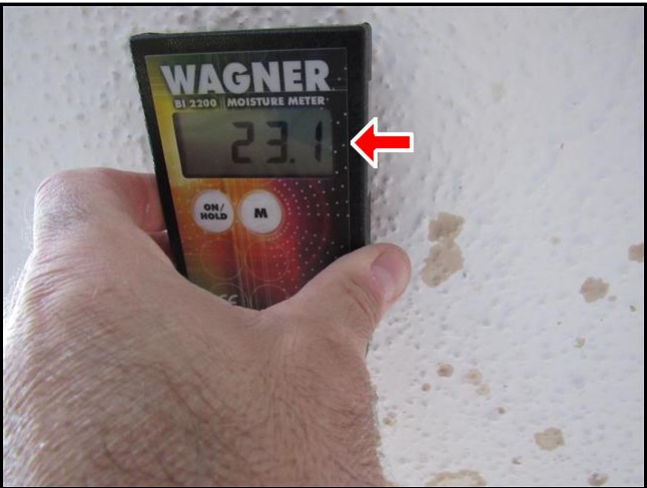
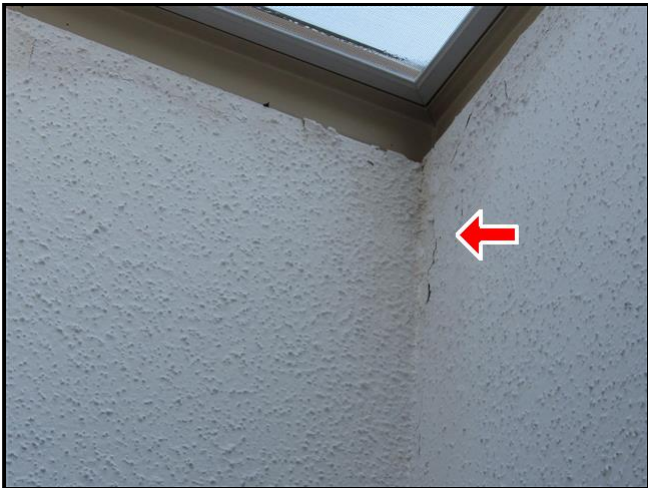
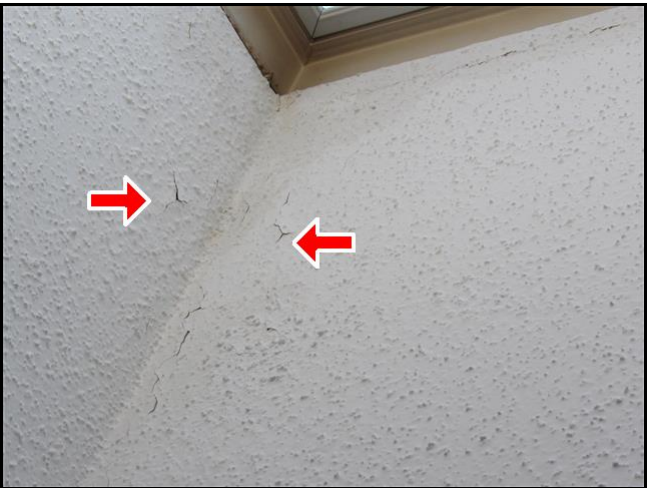
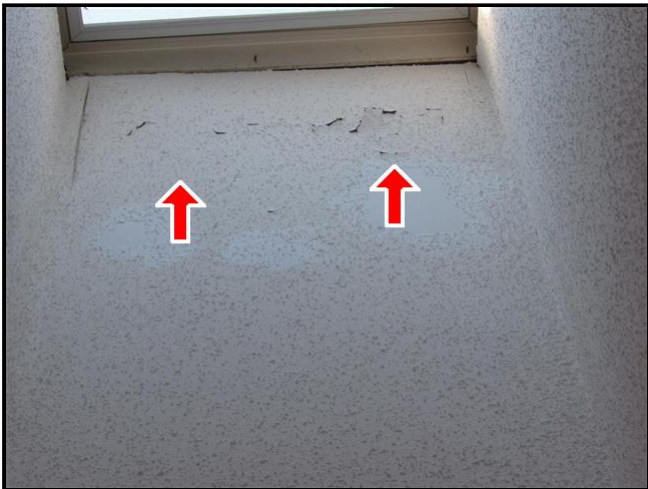
Stains on the ceiling in the kitchen between the sky lights visible at the time of the inspection appeared to be the result of roof leaks. The moisture meter showed elevated levels of moisture present in the affected areas at the time of the inspection, indicating that the leakage may have been recent. Also peeling textured paint was visible on the sheetrock near the skylight. A licensed contractor should be consulted to identify the source of the leak and repair as necessary.

The textured paint near the skylights in the bathrooms was peeling which may be an indication of excessive moisture. A licensed contractor should be consulted to determine the cause of the peeling and make any necessary repairs.

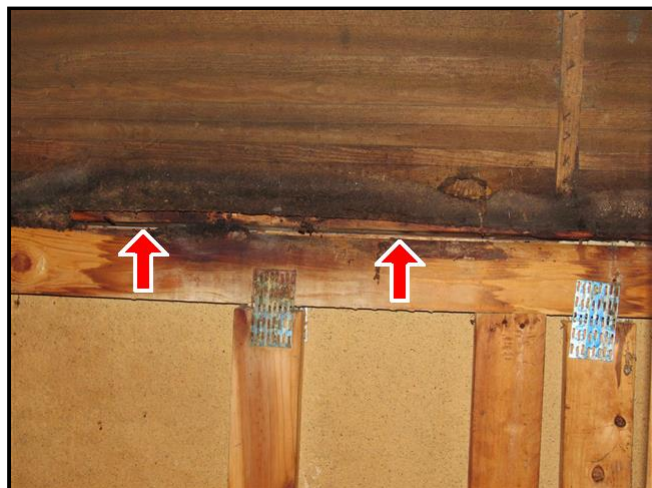
5.5 Item 1(Picture)

In the attic at both ends of the gable vent I observed the screen separating the interior of the attic from the exterior, broken at the bottom of the vent with large quantities of possible bat guano on the screen. I also observed a mound of possible bat guano on top of the insulation and below the vent near on the end of the house near the master bedroom. A qualified contractor should be consulted to repair the screens and also clean the possible bat guano.

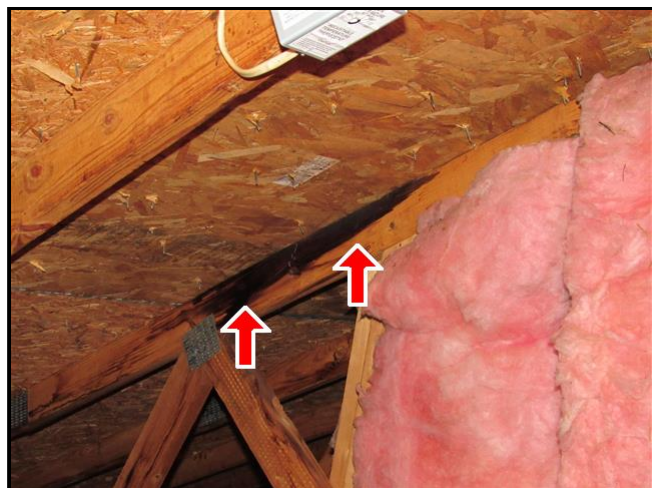
5.5 Item 3(Picture)

In the attic near the location of the skylights at the master bedroom side of the house I observed discoloration of the roof truss from possible water penetration. At the time of this inspection the discoloration did not appear to be wet, however as stated earlier in the report, a licensed contractor should be consulted to determine if leaks are present and make any necessary repairs.

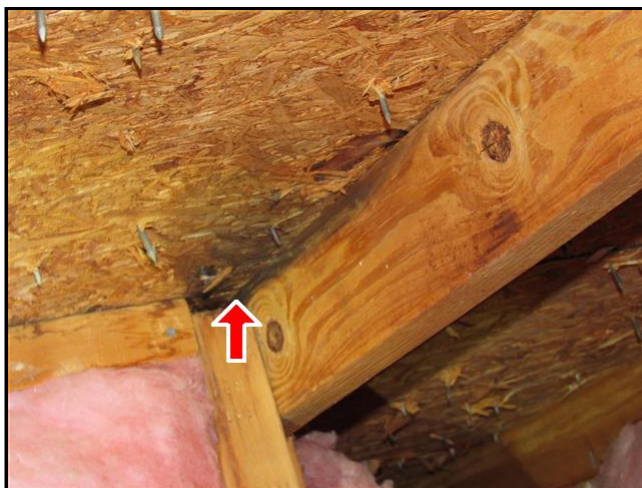
5.5 Item 4(Picture)

In the attic area near the location of the skylights above the kitchen I observed discoloration of the roof sheathing from possible water penetration. At the time of this inspection the discoloration did not appear to be wet, however as stated earlier in the report, a licensed contractor should be consulted to determine if leaks are present and make any necessary repairs.

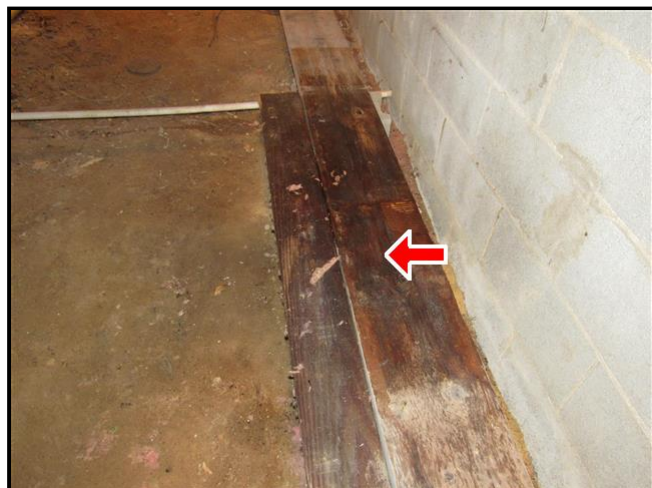
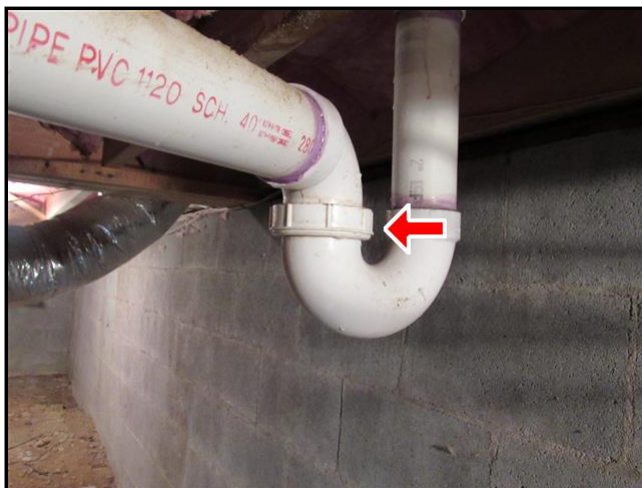
In the crawl space just as you enter from the basement access door I noticed the wood on the crawl space floor wet. I further noticed water dripping from the PVC drain pipe and trap directly above the wood. A licensed plumber should be consulted to evaluate the pipe and make any necessary repairs. Also, the wood should be removed from the crawl space floor so as not to attract wood destroying insects.

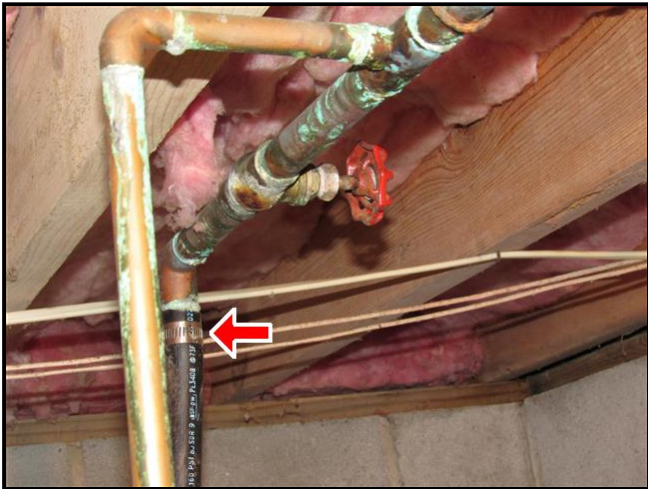
6.1 Item 1(Picture)

In the crawl space near the main water shut off and where the main water supply hose is connected to the copper supply pipe of the home a screw clamp is being used to connect the plastic pipe to the copper pipe. Screw clamps can become loose over time and with the main supply line under pressure this may cause a leak in the crawl space. I recommend that a licensed plumber be consulted to review the connection and make any necessary repairs.

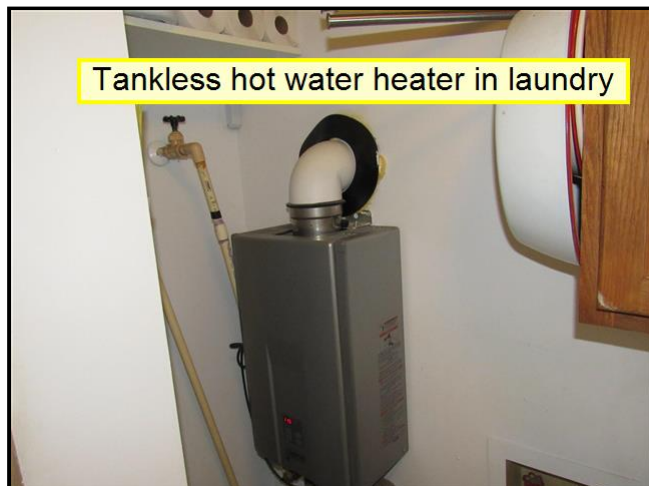
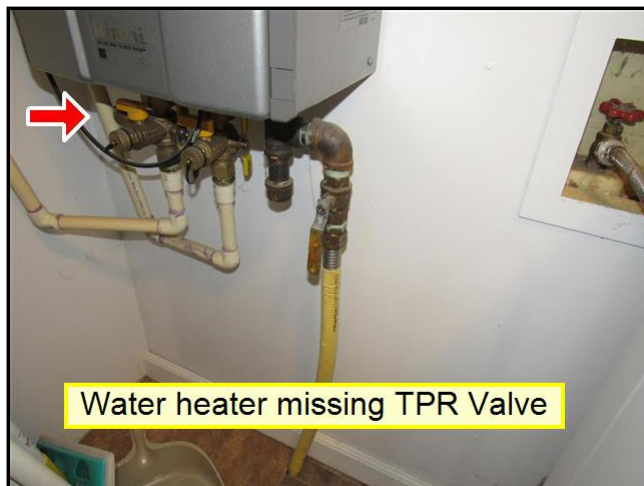
The tankless water heater located in the laundry room is missing a temperature pressure relief valve(TPRV). A TPRV is a safety device that is designed to release water if the tank safety pressure or temperature is exceeded. This is a serious safety concern and should be addressed. I recommend that a licensed plumber be consulted to inspect the water heater and make necessary repairs.

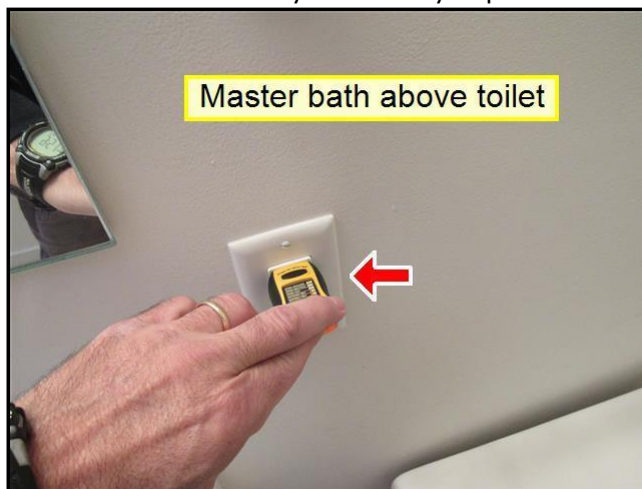
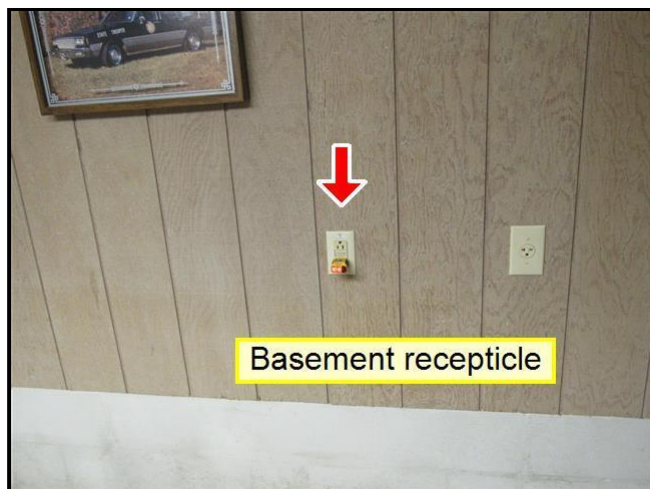
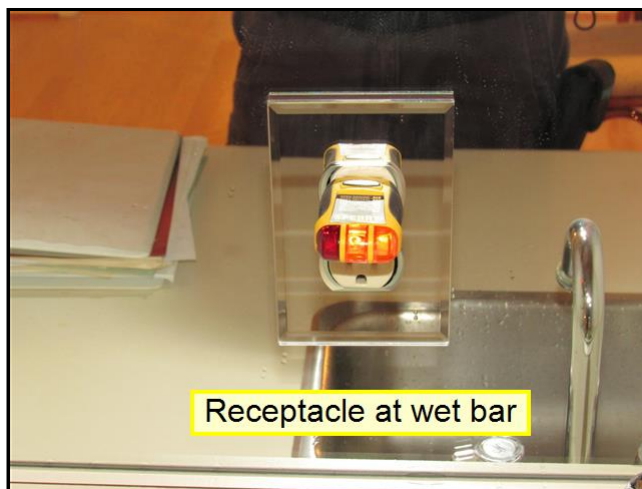
No ground fault circuit interrupter (GFCI) protection of home electrical receptacles was provided or the test function didn't work at the outside receptacles near the front door, master bath near the toilet, outlet above the wet bar sink, and outlet in the basement at the time of inspection. Although GFCI protection may not have been required at the time this home was built, for safety reasons, I recommend that electrical receptacles located in basements, crawlspaces, garages, the home exterior, and interior receptacles located within 6 feet of a plumbing fixture be provided with ground fault circuit

interrupter (GFCI) protection in good working order to avoid potential electric shock or electrocution hazards. I recommend that a licensed electrician evaluate and make any necessary repairs.

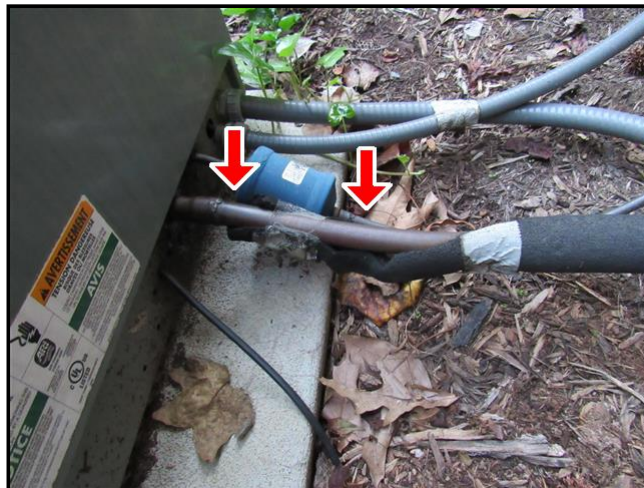
8.0 Item 2(Picture)

The cold line for the heat pump condensing unit outside and the air handler in the crawl space is missing insulation near the unit. I recommend that a qualified HVAC technician be consulted to review and make any necessary repairs.

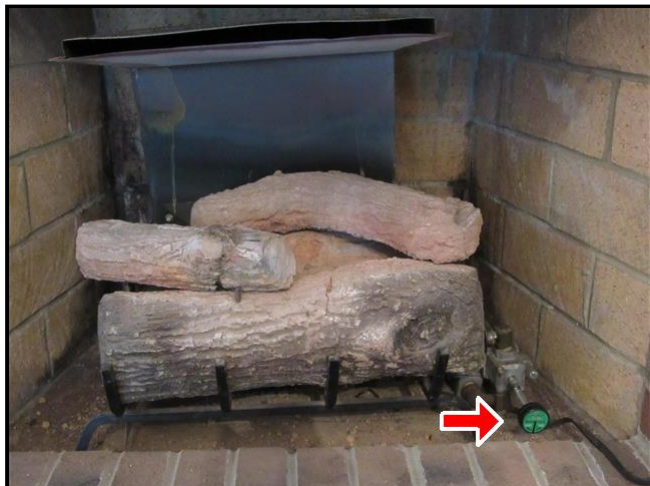
8.7 Item 1(Picture)

The pilot light for the gas logs was off during the inspection. I recommend having a qualified person service the gas logs prior to use.

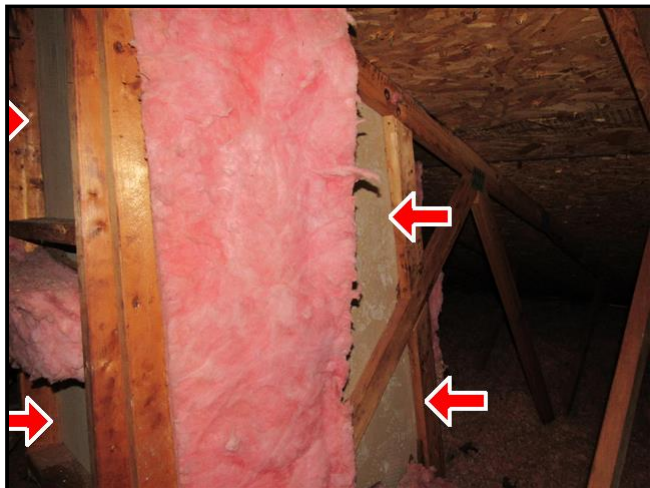
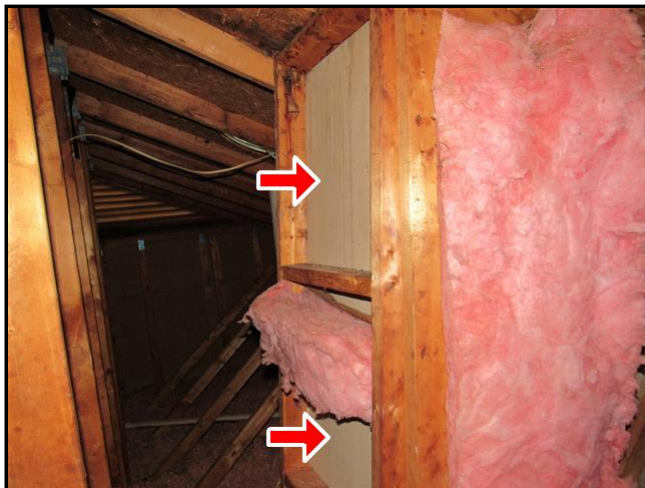
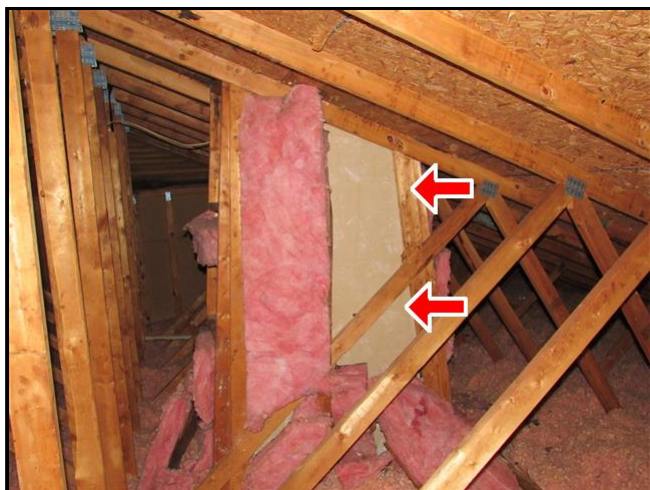
In the attic at the walls going up to the skylights insulation has fallen down and is missing in several areas. It is important to have insulation in areas where conditioned/heated spaces meet non conditioned/heated spaces in order to prevent moisture. I recommend that a qualified contractor review and make necessary repairs.

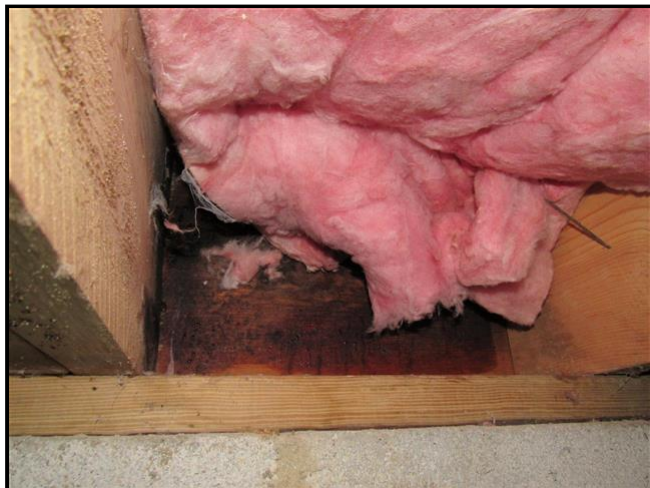
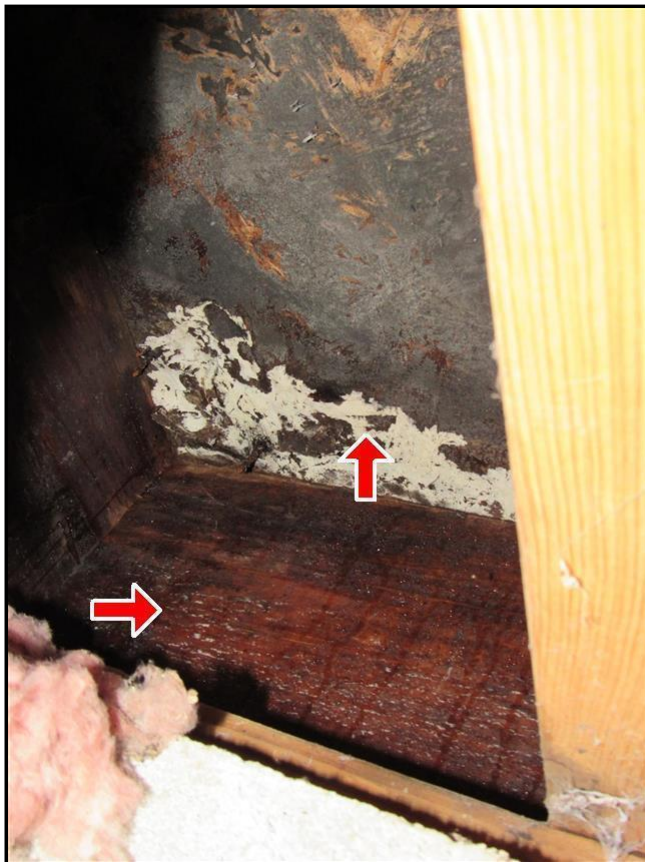
In the crawl space near the outer bands that were discussed earlier in the structural section, several pieces of insulation are wet causing the wood to darken and fungal growth. A qualified contractor should be consulted to review the wet insulation and make necessary repairs.
